# Vigilant Surveys

DAMP AND MOULD INVESTIGATION

## Victorian semi detached house, North London

Specimen report

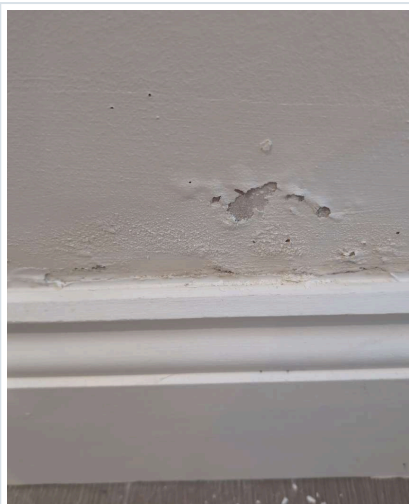
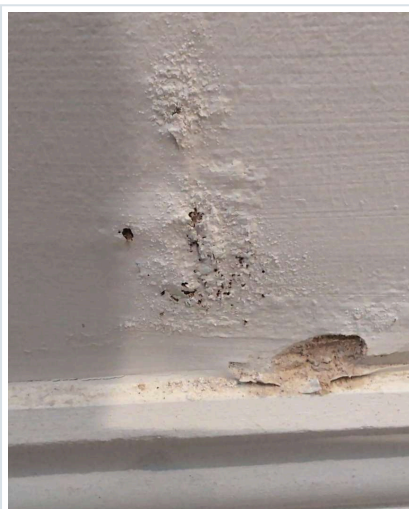
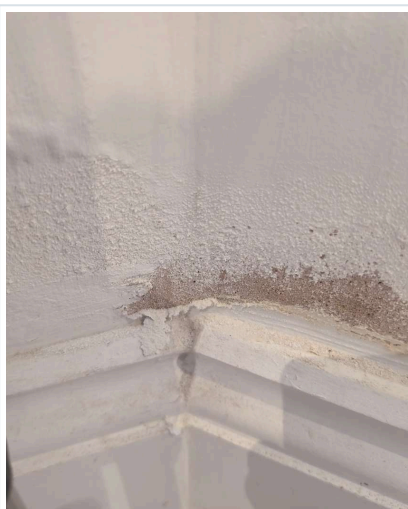
DEFECT  
Side external wall

| MECHANISM | VERDICT | EVIDENCE |
|---|---|---|
| Bridging or construction defect | <b>SUPPORTED</b> | At the front, the render plinth runs down past the slate damp proof course into the ground, and the ground has been built up with concrete to within 70mm of the damp proof course. At the rear and along the rear side wall of the kitchen projection, the render sits in contact with the paving. Both bridge the damp proof course, and both hard surfaces throw rain back onto the base of the wall. The kitchen external side wall reads 14 to 20 %WME at skirting level against a control of 8.8. |

5. **Repair and refix the render where it has come away at the top of the kitchen side wall, so the junction with the brickwork above sheds water.**

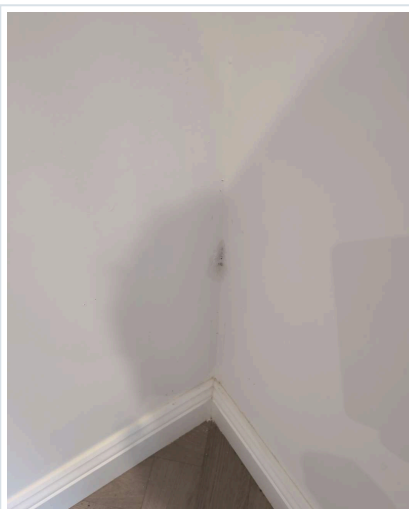
DEFECT  
Side corner of external wall

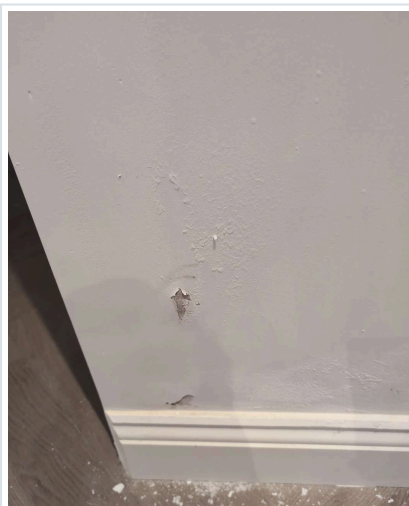
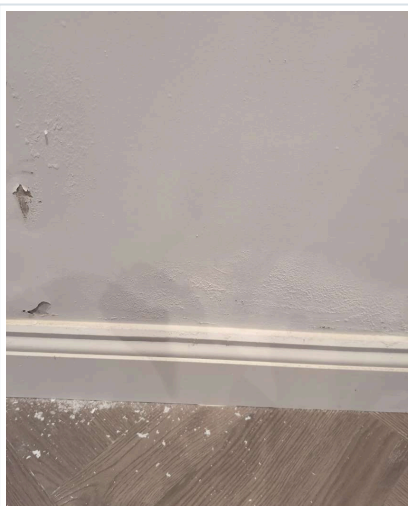
DEFECT  
Internal partition wall to living room

The worst wall, the kitchen partition, has no outside face. Its readings are highest at 600mm with a drier base, which is not rising damp, and the salts test confirms the white deposits are efflorescence rather than ground salts. Efflorescence is left behind as water dries out of a wall, so this wall is taking on moisture from somewhere, and the new decoration is failing where it comes out. The source was not established on the day. The void beneath the living room floor beside it, ventilated with damp cellar air, is the first place to look, by lifting a floorboard, with drilled samples to measure the moisture in the wall itself.

13. **Once the sources are stopped and the walls have had a drying period, brush the salt deposits off dry, make good the blown plaster in the kitchen and behind the front living room radiator, and redecorate with a breathable paint. Replaster with a system suited to salt contaminated masonry only where drilled samples show the plaster is still holding moisture.**

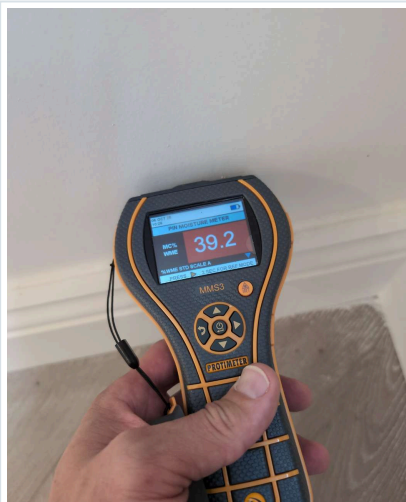
DEFECT  
External wall left of front window

| MECHANISM | VERDICT | EVIDENCE |
|---|---|---|
| Penetrating damp, building defect | <b>CANNOT BE EXCLUDED</b> | The living room side wall reads 17 to 18 %WME in patches below 900mm, and a neighbouring lean to structure is built against the side of the house outside, so that wall could not be inspected. At the front, the cement flashing where the canopy roof meets the wall is degraded and the canopy gutter is not fitted correctly, above the cold front corner of the living room. |

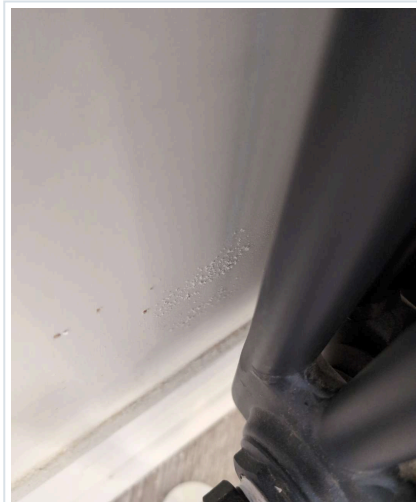
DEFECT  
Salting signs behind front wall radiator

**URGENT** The living room readings are grouped around this radiator, 49.9 %WME left of it and 24.4 right of it, with salts on the wall behind it and dry wall either side. The property was empty, so no history of the heating was available. A pressure test is quick, and should come before drilled samples so that a leak is not mistaken for anything else.

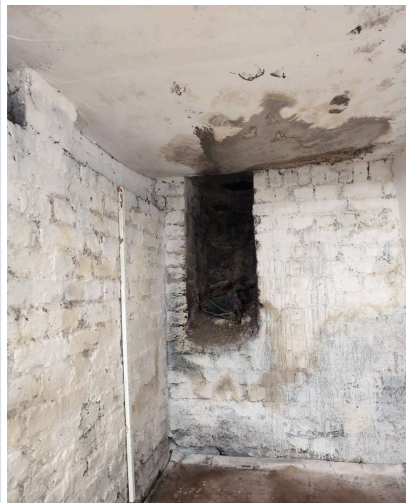
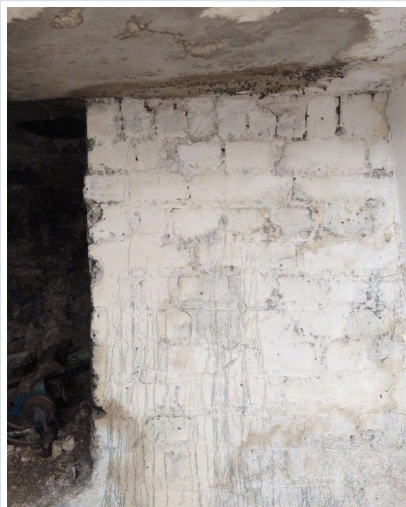
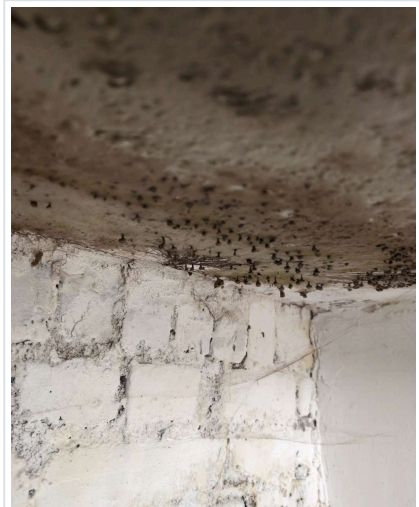
| Other observations | Salting efflorescence, Peeling paint, Staining |

**MODERATE** The cellar has no ventilation, the air was at 73.6 per cent, and the coldest wall was 4 degrees below the dew point, so condensation forms on its walls and mould is growing on the ceiling. The staining around the chute suggests water entering at the front. The drilled holes in the cellar wall appear to vent the void beneath the living room floor, so that void is being ventilated with this damp cellar air.

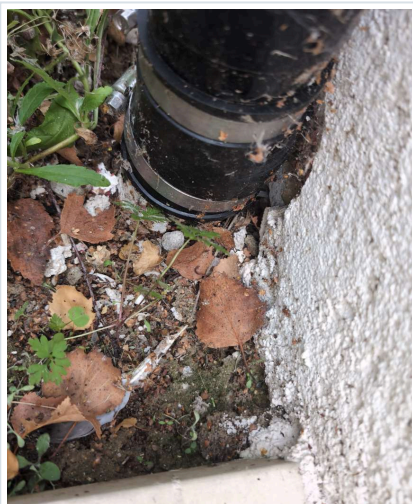
**SEVERE** Rainwater from the roof is going into the ground beside the kitchen with no proven route away, next to a wall that reads 14 to 20 %WME at skirting level. A blocked gully does the same. The cost of this depends on the extent found once the work is opened up. Obtain a written quotation.

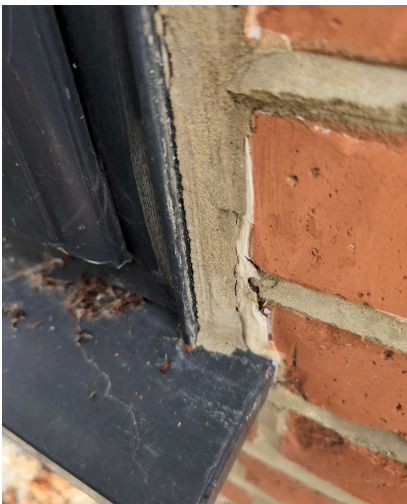
POINTING RENDER  
Lose mortar bottom right or window

**MODERATE** Loose mortar at the window lets rain into the wall at the reveal, beside the front corner where elevated readings were found.

9. **Repoint the loose mortar at the bottom right of the front window.**

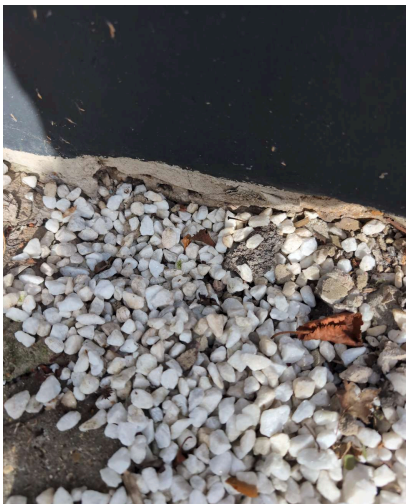
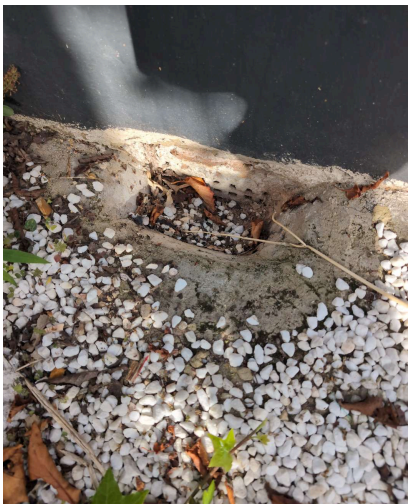
**SEVERE** The air bricks are at ground level and partly blocked by gravel and mortar. They ventilate the space under what appears to be a suspended timber floor. Blocked air bricks leave that space damp, which puts the floor timbers at risk and adds moisture to the base of the walls.

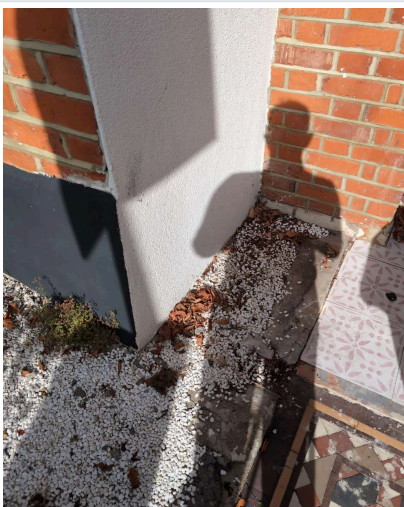
DEFECT  
Slate DPC In bottom right of this picture

Outside, at the front. A slate damp proof course is visible at the corner of the bay. A painted render plinth to about 600mm runs down past it into the ground, so it bridges the damp proof course. The ground has been built up with concrete against the wall, with gravel over it, and at worst sits only 70mm below the damp proof course, left of the front step, where 150mm is the usual minimum. The air bricks sit at ground level, partly blocked by gravel and mortar. The canopy roof over the bay and front door meets the wall with an old cement fillet, degraded in places, and its gutter is not fitted correctly. There is loose mortar at the bottom right of the front window.

**SEVERE** The render plinth runs down past the damp proof course into the ground, and the concrete and gravel sit as little as 70mm below it, so moisture and rain splashing back off the hard surface pass straight up past it. The air drain is preferred because it lowers the ground level against the wall and stops rain splashing back onto it. Cutting back the plinth frees the damp proof course itself and lets its line be seen and checked. Doing both deals with each. The indicative cost covers the air drain along the front, about 4 metres. Cutting back the render plinth is not included; obtain a written quotation for it.
