# Vigilant Surveys

DAMP AND MOULD INVESTIGATION

## Semi detached house, North London

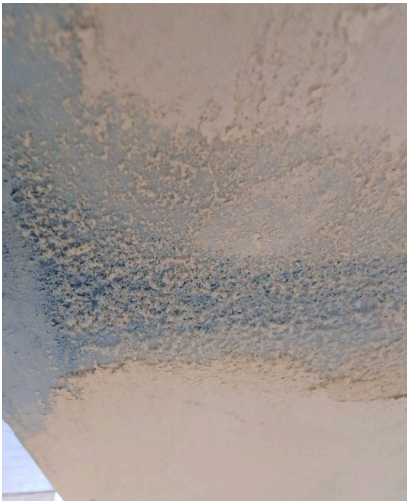
DEFECT  
Blown plaster and staining above the skirting

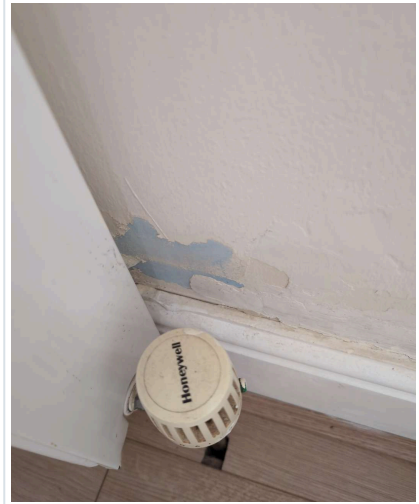
DEFECT  
Damage directly above the radiator  
valve

2. **Have the central heating system pressure tested, including the radiator valve and pipework at the chimney breast return, and repair any leak found.**

**URGENT** The boiler has to be topped up about five times a year, so water is being lost from the system, and the radiator valve sits directly below the damage. This needs doing before any samples are taken. Suitable trade: a heating engineer or plumber. If the boiler itself needs work, a Gas Safe registered engineer.

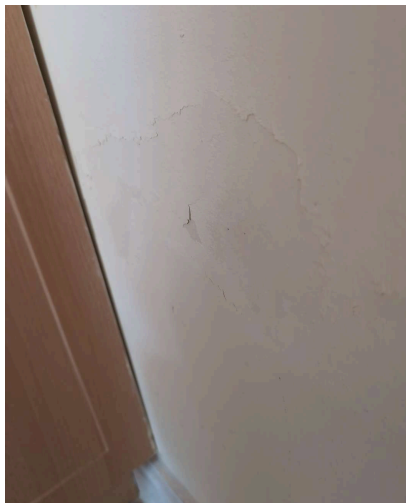
| <b>SOFT, CRUMBLING PLASTER WITH SALTS</b> | |
| Surface | Wall |
| Whereabouts | Left of the door to the living room, above the skirting |
| Observed | Salting efflorescence |
| Reading on it | <b>23 %WME</b> Left of the living room door, the kitchen face of the same wall against a control of 9.8 |

DEFECT  
Kitchen side: soft, crumbling plaster left of the living room door

6. **Once the leaks are found and repaired and the wall has had a drying period, remove the salt contaminated plaster from the chimney breast, its return and both faces of the wall to the kitchen. Take it to at least 1m, or 300mm above the highest salt level shown by the drilled samples, whichever is greater, replace the corroded metal corner beads, and replaster with a system designed for salt contaminated masonry.**

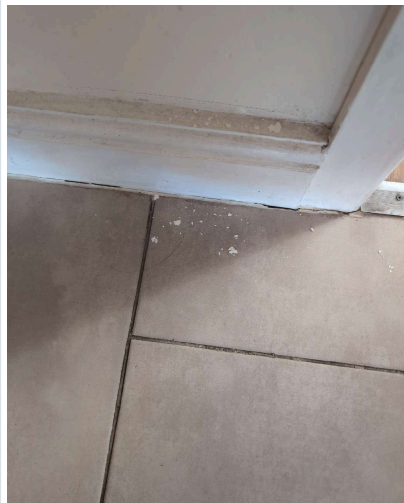
DEFECT  
Plaster debris on the floor tiles at the foot of the wall

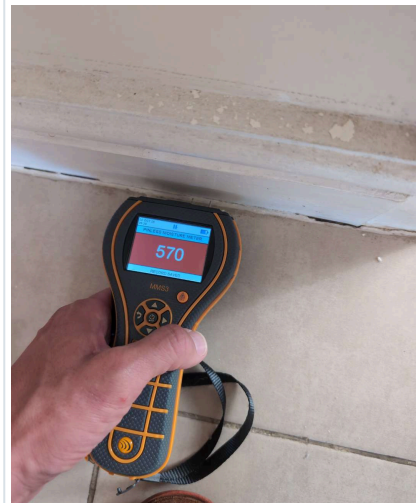
DEFECT  
Pinless reading on the floor at the foot of the wall

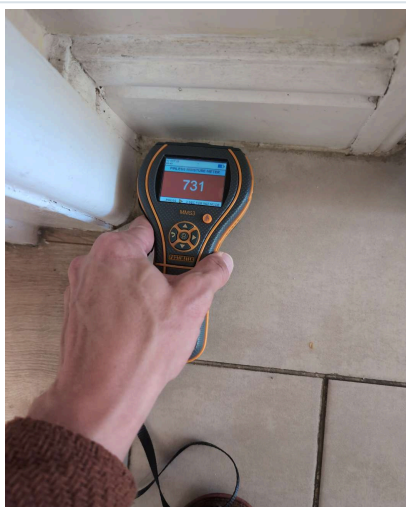
DEFECT  
Pinless reading at the foot of the wall right of the door

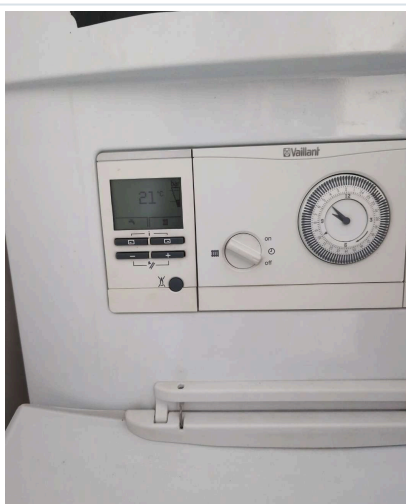
DEFECT  
The boiler, which the owner reports has to be topped up regularly

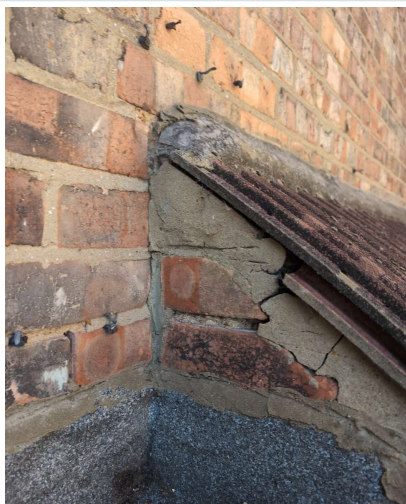
Lean-to roof abutment: cracked and detached cement fillet

| MECHANISM | VERDICT | EVIDENCE |
|---|---|---|
| Penetrating damp, building defect | <b>CANNOT BE EXCLUDED</b> | The cement fillet where the lean-to roof meets the main wall has cracked and come away from the brickwork, and the cement verge has shrunk. Rain running down the wall can get in behind it. From outside this roughly corresponds to the affected corner, and it fits the owner's account that the damp is worse in wet weather. The chimney stack has been removed and the top of the flue could not be seen. |

3. **Re-form the junction of the lean-to roof with the main wall with a proper flashing in place of the cracked cement fillet, and repair the cement verge.**

**URGENT** The cement has cracked and come away from the brickwork, so rain running down the wall gets in behind it and into the wall below the affected corner. Anything letting water into the structure is urgent. Suitable trade: a roofer.

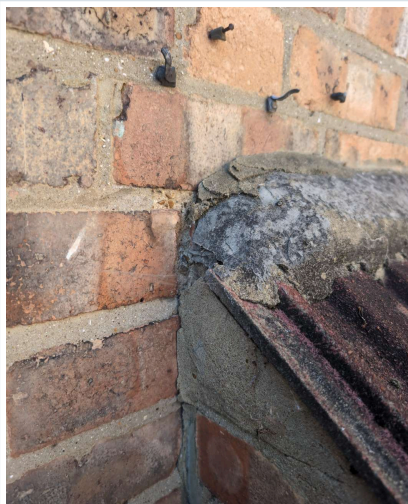
Lean-to roof verge: cement shrunk away from the brickwork

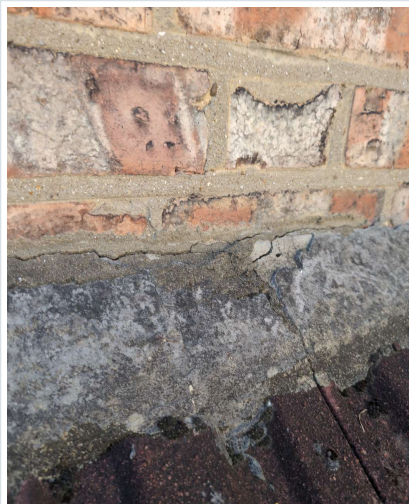
Cement verge cracked along its length

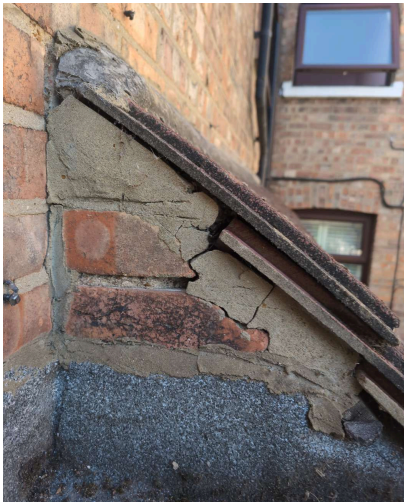
The cracked verge and fillet, with water able to get behind it

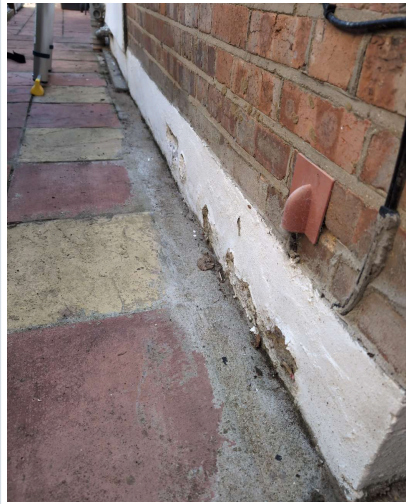
Render plinth taken down to the paving, blown around the air brick

| Bridging or construction defect | <b>CANNOT BE EXCLUDED</b> | No damp proof course could be seen: the render plinth runs down to the level paving and is blown around the air bricks, and rain splashes back off paving onto the base of a wall. This is a defect to make good, but the affected walls are internal and the external wall of the room reads dry, so it does not explain the corner. |

**MODERATE** The render runs down to the level paving, so any damp proof course is bridged, and rain splashing back off the paving wets the base of the wall. The render is already blown around the air bricks. This is a defect to make good rather than the cause of the damp in the corner. Suitable trade: a general builder or a plasterer who does external rendering.

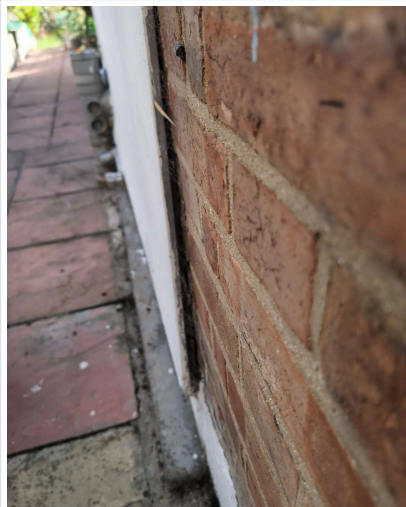
Open joint between the render and the brick at the window

**MODERATE** An open joint on an exposed wall lets rain into the wall behind it. It is a simple repair. Suitable trade: a general builder.
