# Vigilant Surveys

DAMP AND MOULD INVESTIGATION

## Upper floor flat, North London

Specimen report

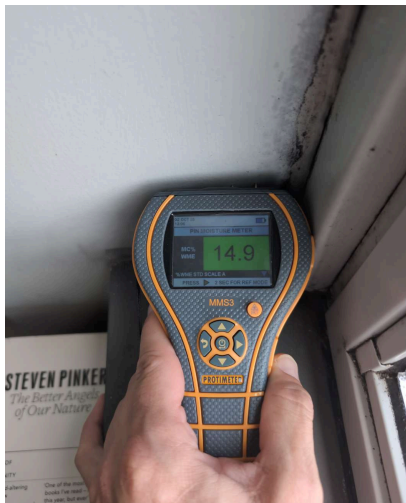
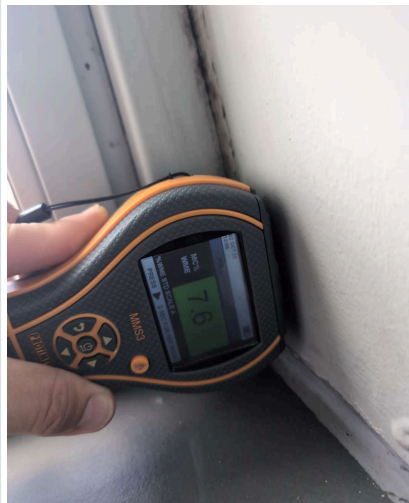
| Reading on it | <b>14.9 %WME</b> Left side of window reveal against a control of 8 |
| Reading on it | <b>7.6 %WME</b> Right side of window reveal against a control of 8 |

METER SHOWING THE READING

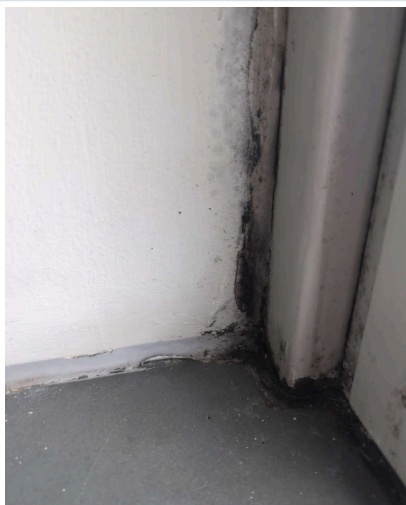
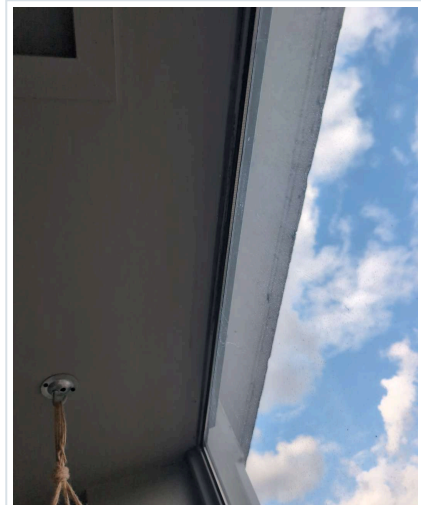
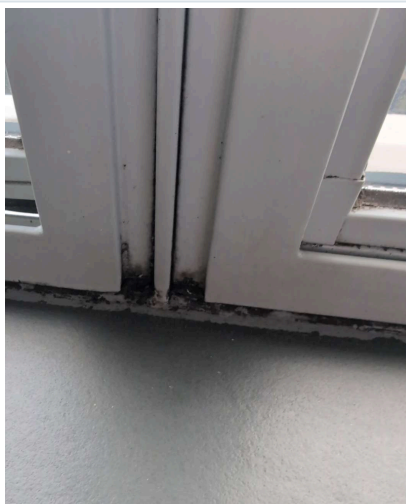
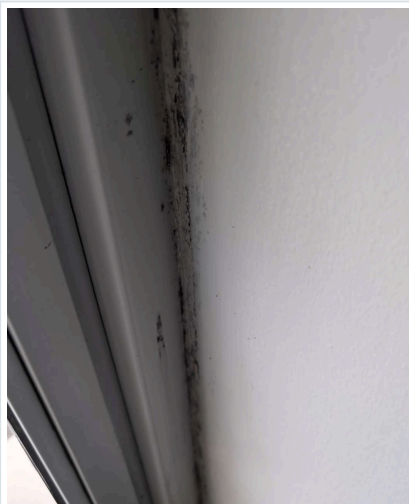
| Observed | Peeling paint, Mould |

DEFECT

The living room. Black mould runs along the sealant where the steel frames meet the plaster and the sills, and onto parts of the reveals, heaviest in the bottom corners where water running off the glass collects. There is some peeling paint. The left reveal reads 14.9 %WME where the mould is heaviest, the right reveal 7.6, against a control of 8.0 on an internal wall.

6. **Once the moisture is under control, cut out the mould stained silicone where the frames meet the plaster and the sills, and reseal with a silicone containing a mould inhibitor.**

7. **After the sealant, rub down the affected reveals, prime with a mould resistant primer and finish to match the room.**

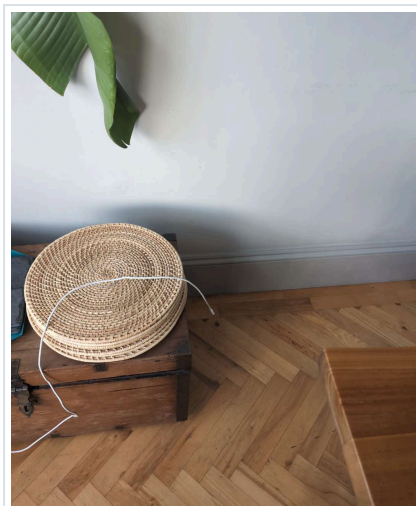
CONTROL LOCATION

| Control reading | 8 %WME. Internal wall, away from the windows |

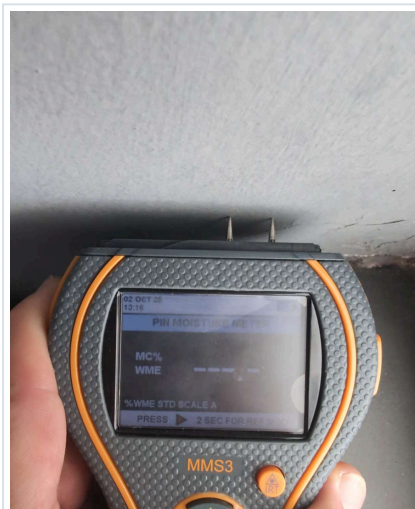
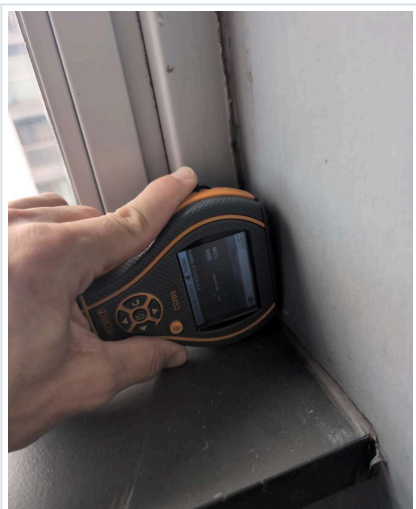
| Reading on it | <div>LO</div> Below 6 %WME, the lower limit of the meter. Window reveal, beside the frame |

METER SHOWING THE READING

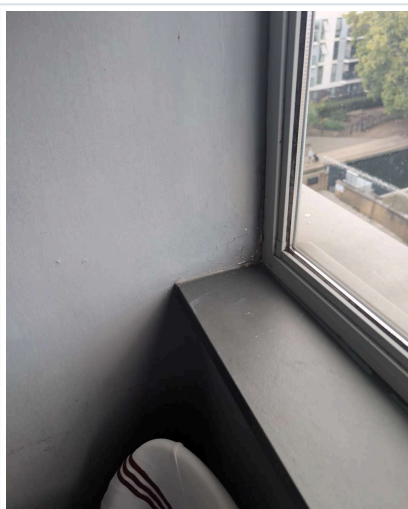
WHERE THE READING WAS TAKEN

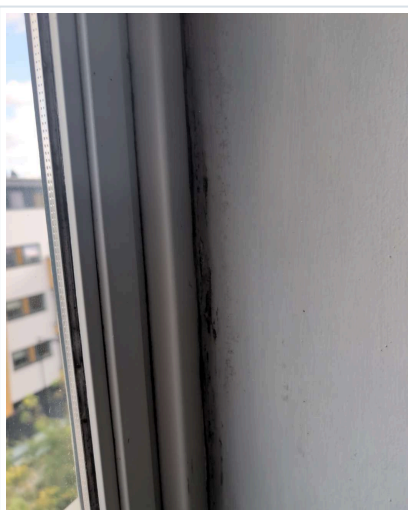
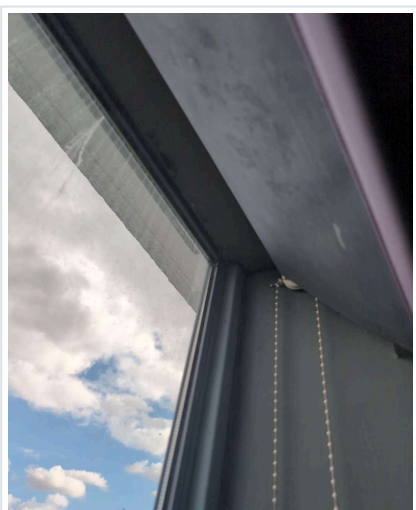
DEFECT

Bedroom 1. Mould and staining to the window reveals and along the sealant, the same pattern as the living room. Both reveal readings were below the range of the meter, against a control of 8.2 on the partition to the office.

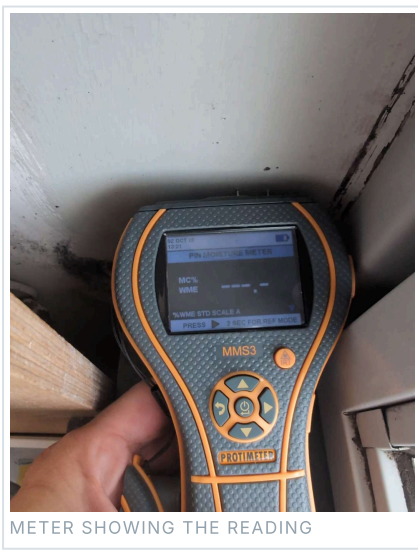
| Reading on it | <b>LO</b> Below 6 %WME, the lower limit of the meter. Window reveal, beside the frame |

METER SHOWING THE READING

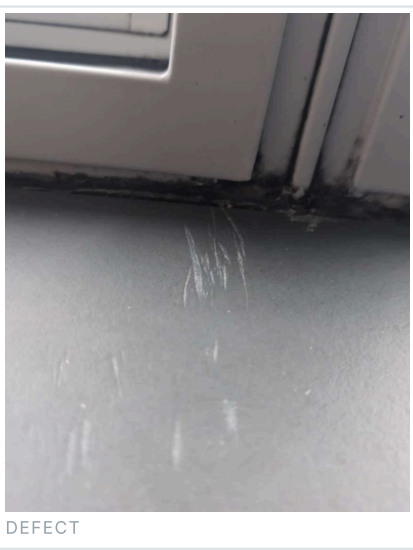
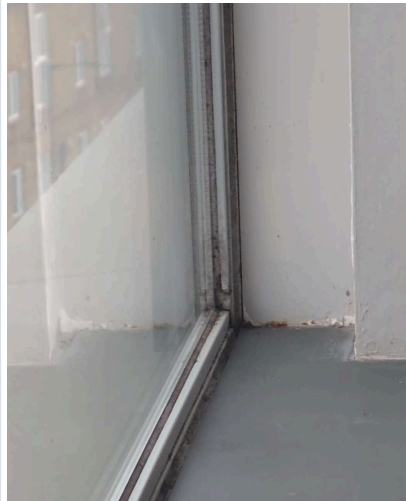
DEFECT

The home office. Mould, staining and peeling paint to the window reveals, the same pattern again. The reveal reading was below the range of the meter, against a control of 7.3 on the partition to the bedroom. Mould also forms low on the external wall behind the desk, where furniture and boxes stand hard against it. That wall was the coldest surface found in the room, at 21.6 degrees.

4. **Keep furniture and stored boxes a hand's width off the external walls, in particular behind the desk in the home office.**

**MODERATE** Furniture against a cold external wall stops warm air reaching the surface behind it, so it stays cold and mould grows there. This is what is happening behind the desk.

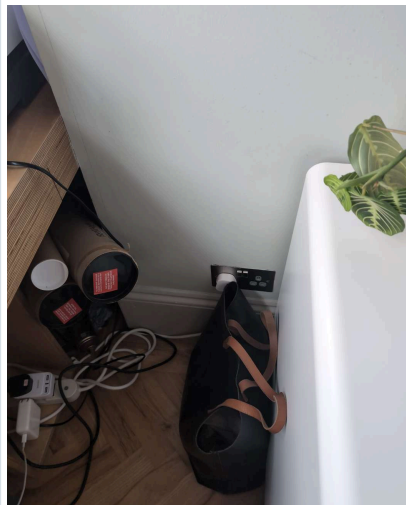
CONTROL LOCATION

| Control reading | 7.3 %WME. Internal partition wall to bedroom 1 |
