# Vigilant Surveys

DAMP AND MOULD INVESTIGATION

## Detached house, Essex

Inspected September 2026

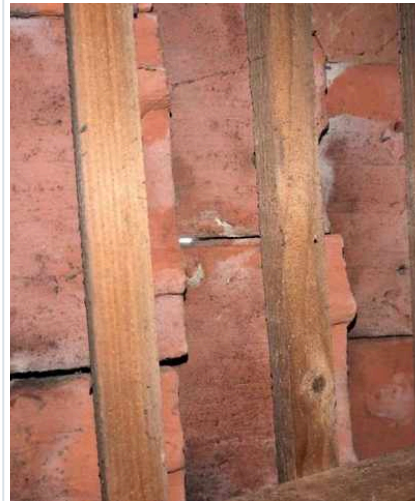
**17.8 %WME** Underside of a tile batten between the rafters above the loft hatch, in the bay with the gap in the tiles, batten and tiles stained

DEFECT  
Gap in tiles course

Loft. The roof is clay plain tiles on battens with no underlay beneath them, and daylight shows through a gap in one tile course. Rafters, purlins and plates read between below range and 9.9 %WME. Readings rise on the battens directly under the tiles, to 10.2 and 12.5, and reach 17.8 on a batten between the rafters above the loft hatch, in the same bay as the gap, where the batten and the underside of the tiles are stained. That is rain getting past the tiles at that point. It is the only elevated timber reading in the roof and no decay was seen, although timber decay is outside the scope of this report.

**MODERATE** Daylight shows through the gap and the batten directly beneath it is the only elevated timber reading in the roof, with staining on the batten and the tiles. With no underlay, any rain that passes the tiles lands straight on the timbers below.

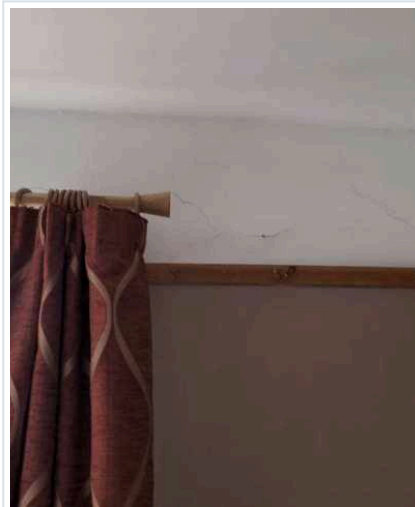
| Wall | <b>20.1 %WME</b> Front external wall, plaster between the picture rail and the ceiling at the top right of the window, cracked and blown |

DEFECT  
External front elevation wall

Bedroom 1, behind the right hand of the two first floor windows on the south front and so on the south east corner. One reading is elevated, 20.1 %WME in the band of plaster between the picture rail and the ceiling on the south wall, at the top right of the window, where the plaster is cracked and blown. Every reading at skirting level, on the other walls and inside the built in cupboard is below range. A wet reading confined to the head of a wall with dry plaster below it is water arriving from above, not from the ground. The render on the south elevation is sound, there is no plumbing above this part of the room, and the verge tiles above are bedded onto the render with no undercloak. The highly probable route is rain getting in at the roof, at the verge or the roof covering above it, and working down into the head of the wall. The only other explanation is past ingress that was never made good. The roof repair recommended below answers either. On the east wall behind the bed, small spots of flaking paint with white deposits read 7.9, dry.

#### **3. Have the verge and the roof covering above the south wall of bedroom 1 inspected and put right where defective.**

**MODERATE** The head of the wall in bedroom 1 reads wet with the plaster cracked and blown, while the render below is sound and there is no plumbing above. The verge tiles are bedded onto the render with no undercloak. Rain getting in at the roof here and working down is the highly probable cause.

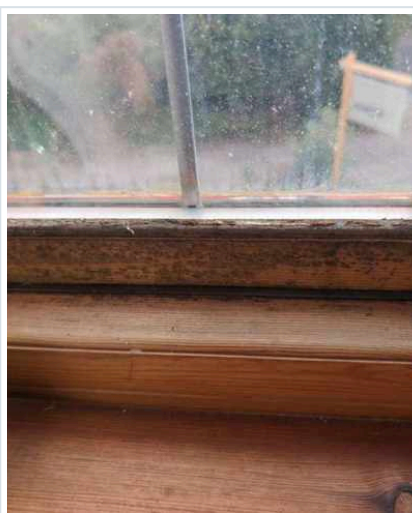
DEFECT  
Window frame south elevation

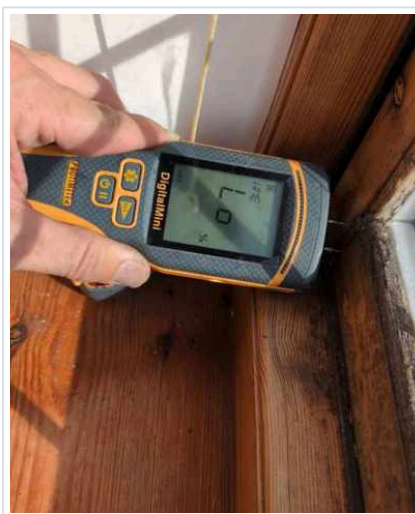
DEFECT  
Window frame south elevation

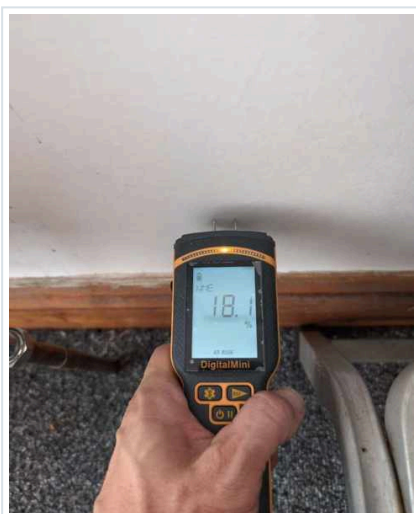
DEFECT  
South external wall

but well above the control, which was below the lower limit of the meter. The highest readings are on the south external wall around the radiator below the window: 25.1 just above the skirting at one end of the radiator, 20.3 beside its other end, 18.1 on its other side and 17.6 just below the window sill. The window frame timber is dry but heavily marked with mould along the glazing bead. The door has no undercut at all, the window has no trickle vent and there is no extract, so moisture in this room has no way out while the door and window are shut. A room slightly damp throughout, with the worst of it on the coldest external wall under the window, is the pattern of moisture held in the room and settling on its coldest surfaces. Water through the south wall below the window cannot be excluded.

**10. Improve ventilation: undercut the bedroom 2 door to give a clear 10mm gap, set the downstairs WC extract to run on a humidity control or an overrun timer, confirm that the kitchen cooker hood discharges outside, fit a vent to the sealed chimney breast in bedroom 3, and ventilate the under stairs cupboard.**

**MODERATE** Bedroom 2 reads raised throughout with no door undercut, no trickle vent and no extract, so moisture in that room has nowhere to go. The mould in the WC is at high level with dry walls, which is condensation that the extract is not clearing when it relies on being switched on. The cooker hood discharge was not established. A sealed flue with no vent traps moisture in the chimney breast. The under stairs cupboard has mould, no ventilation and no heat.

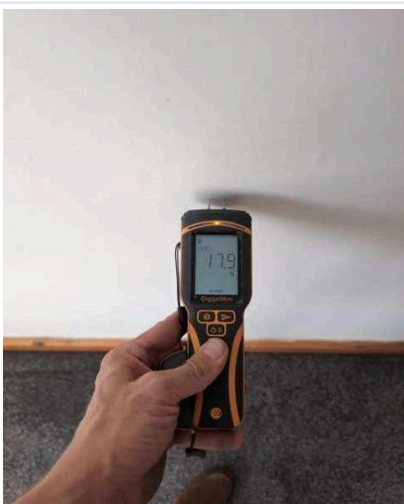
DEFECT  
West external wall

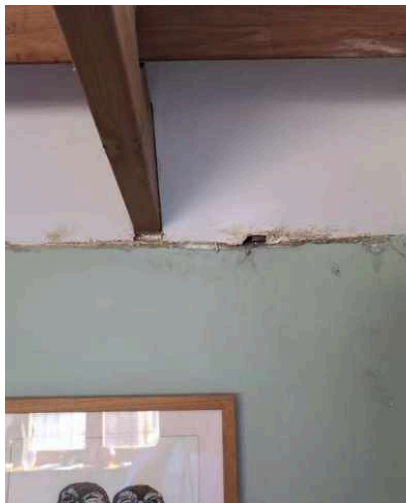
| Junction | <b>LO</b> Below 6 %WME, the lower limit of the meter. In the damaged filler at the ceiling and wall junction beneath the rooflight |
| Junction | <b>12.5 %WME</b> Ceiling and wall junction beside the timber beam, at the damaged area beneath the rooflight |

DEFECT

Upstairs living room. This room sits in the extension, projecting from the west side of the north elevation and reached only from the second entrance. At the junction of the sloping ceiling and the wall, where a timber beam meets it, directly beneath the rooflight, there is tide mark staining, blown and flaking filler, an open hole with a void behind it, and staining running down the wall below. The plaster reveal of the rooflight is cracked at its corner. The junction reads 12.5 %WME and the damaged filler below range, the walls all read below range, and the thermal image shows only 18.5 to 20.6 degrees with no defined cold area. Outside on the north elevation, where the lower roof meets the rendered wall, the render is broken away and patched and the flashing is only partly visible. This is damage from water getting in around the rooflight and the roof abutment, dry on the day. Whether that route has since been closed cannot be seen from inside, which is why the rooflight flashing is to be checked and put right. There is no access to the roof void over the extension, so the timbers around the rooflight opening could not be seen.

#### **4. Have the flashings around the rooflight above the upstairs living room and the abutment where the lower roof meets the wall inspected and renewed where defective, and make good the broken render.**

**MODERATE** The damage at the ceiling junction beneath the rooflight is the result of water

getting in at this point. It is dry today, but the render outside is broken away and patched and the flashing is only partly visible, so the route cannot be shown to be closed. There is no access to the roof void over the extension, so the timbers around the rooflight opening should be inspected when the flashing is opened up.

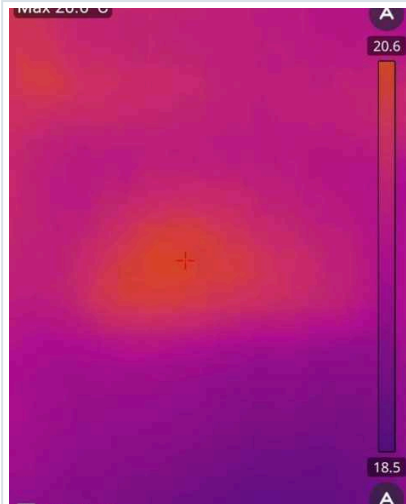
| <b>COLD SPOT FOUND WITH THE THERMAL CAMERA</b> | |

THERMAL

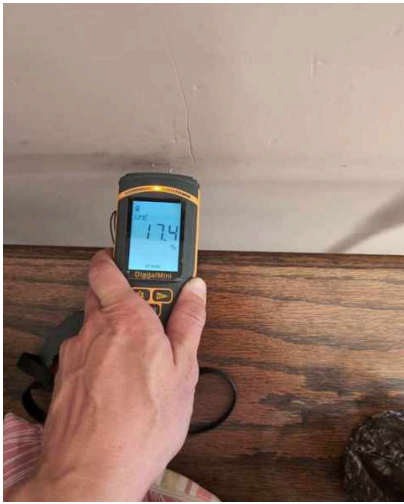
| Wall | <b>17.4 %WME</b> South external wall at about 850mm, directly above a timber board, along a dark band of staining |

DEFECT  
South external wall

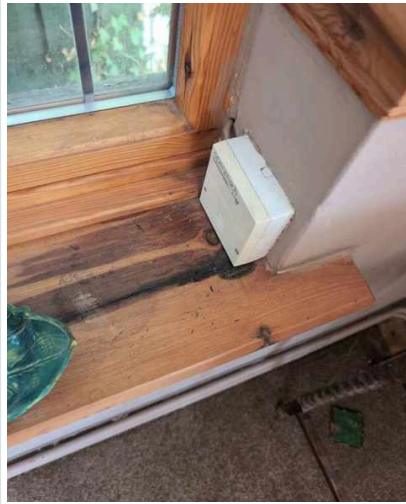
| Timber | <b>10.8 %WME</b> Window board to the east window, heavily stained |

DEFECT  
East external wall window sill

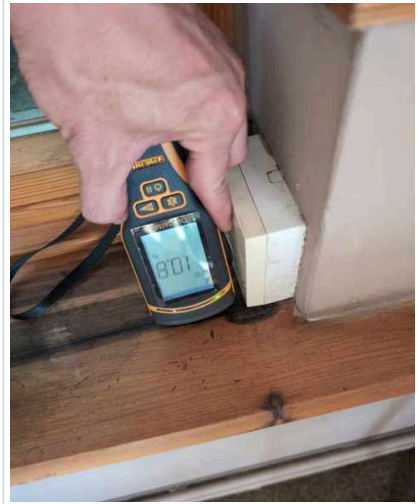
DEFECT  
East external wall windowsill

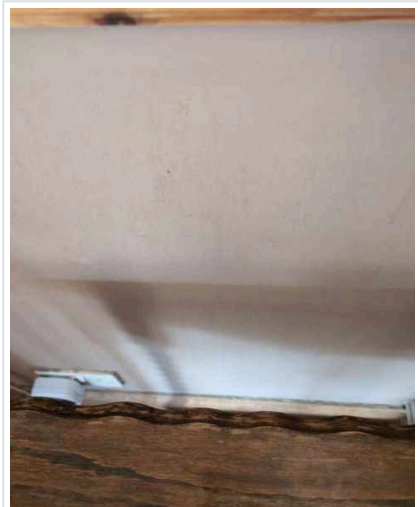
DEFECT  
North wall, faint marking

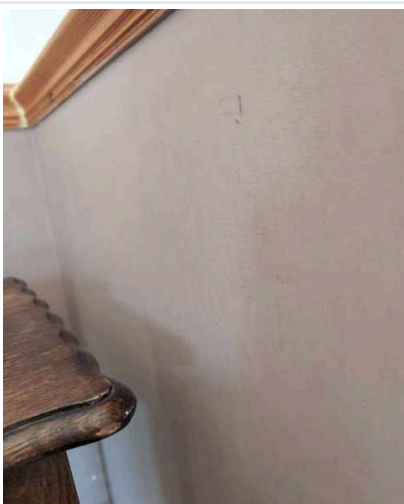
DEFECT  
East wall, faint marking

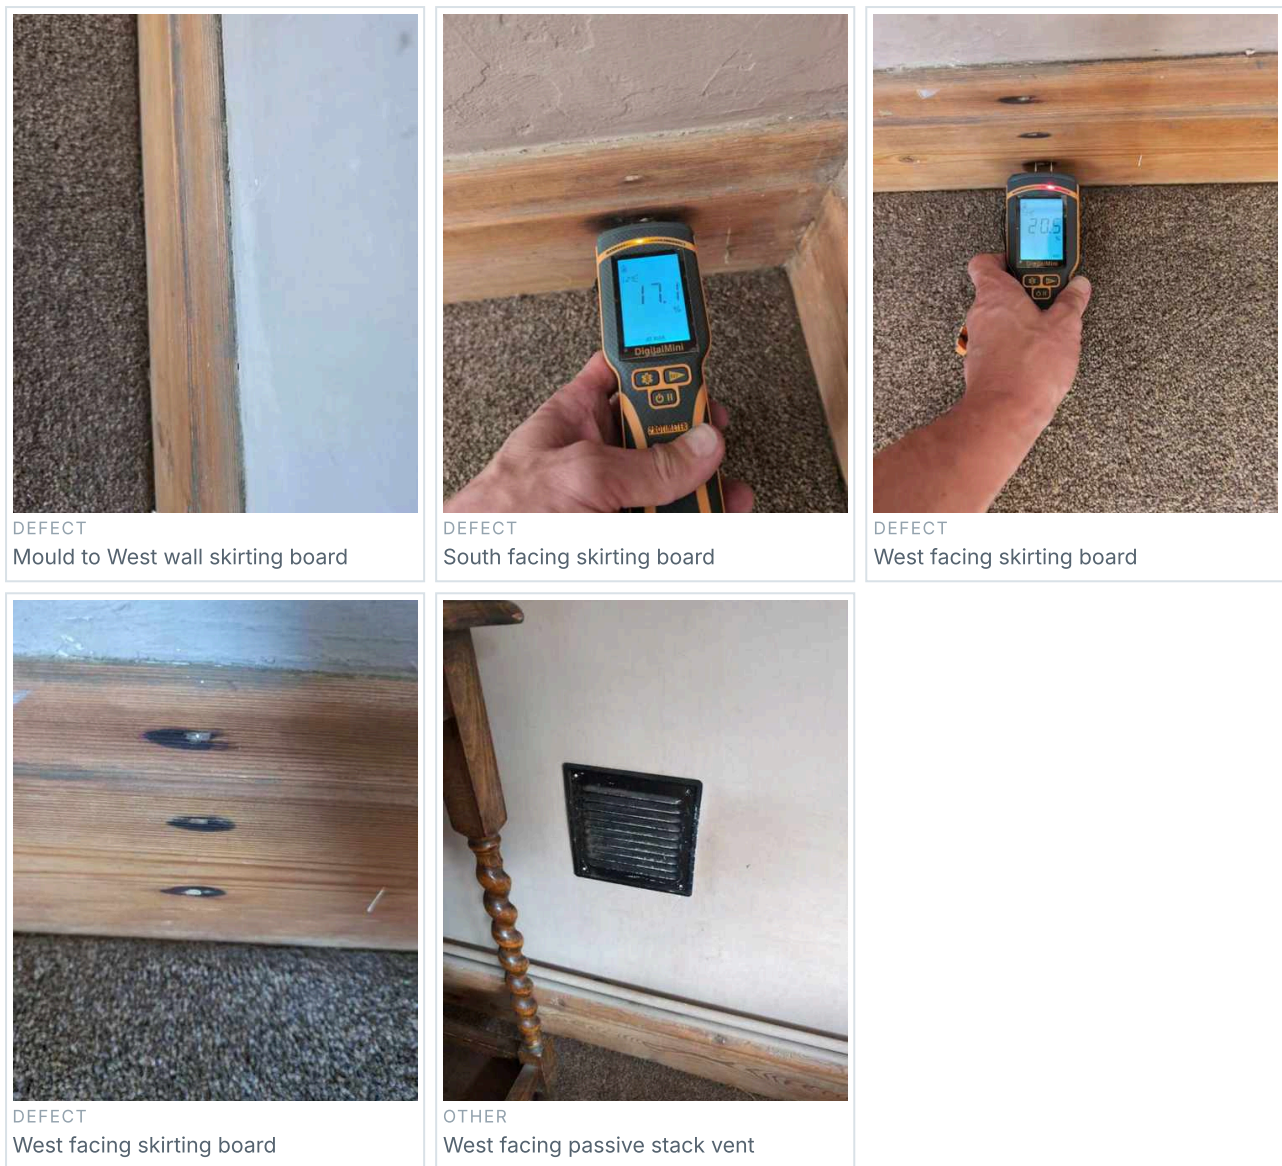
| Skirting | <b>17.1 %WME</b> Timber skirting captioned south facing, mid height of the board at a corner, staining at the nail holes. Taken at a nail fixing into the brick, which reads high on a resistance meter regardless of moisture |
| Skirting | <b>20.5 %WME</b> Timber skirting captioned west facing, bottom edge at carpet level, black staining at the nail heads. Taken at a nail fixing into the brick, which reads high on a resistance meter regardless of moisture |

DEFECT  
Mould to West wall skirting board

DEFECT  
South facing skirting board

DEFECT  
West facing skirting board

South facing living room. Plaster reads below range at low level on every wall. The two higher readings on the timber skirtings, 20.5 and 17.1 %WME, were both taken at a nail fixing, where the nails run into the solid brick wall behind and the timber around each head is stained black. Corrosion of the nail and the staining it leaves conduct electricity, so an electrical resistance meter reads high at a fixing whatever the moisture in the timber, and neither reading is taken as evidence of damp. The plaster immediately above the skirtings is dry. On the south external wall there is a reading of 17.4 at about 850mm directly above a timber board, along a dark band of staining, with faint grey marking on the lower walls on three sides and mould along the joint between the skirting and the plaster. The band above the board is where a cold external wall meets furniture placed against it, and together with the grey marking is consistent with condensation.

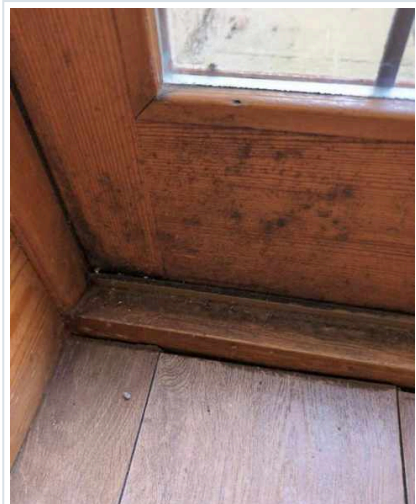
DEFECT  
Staining to French doors

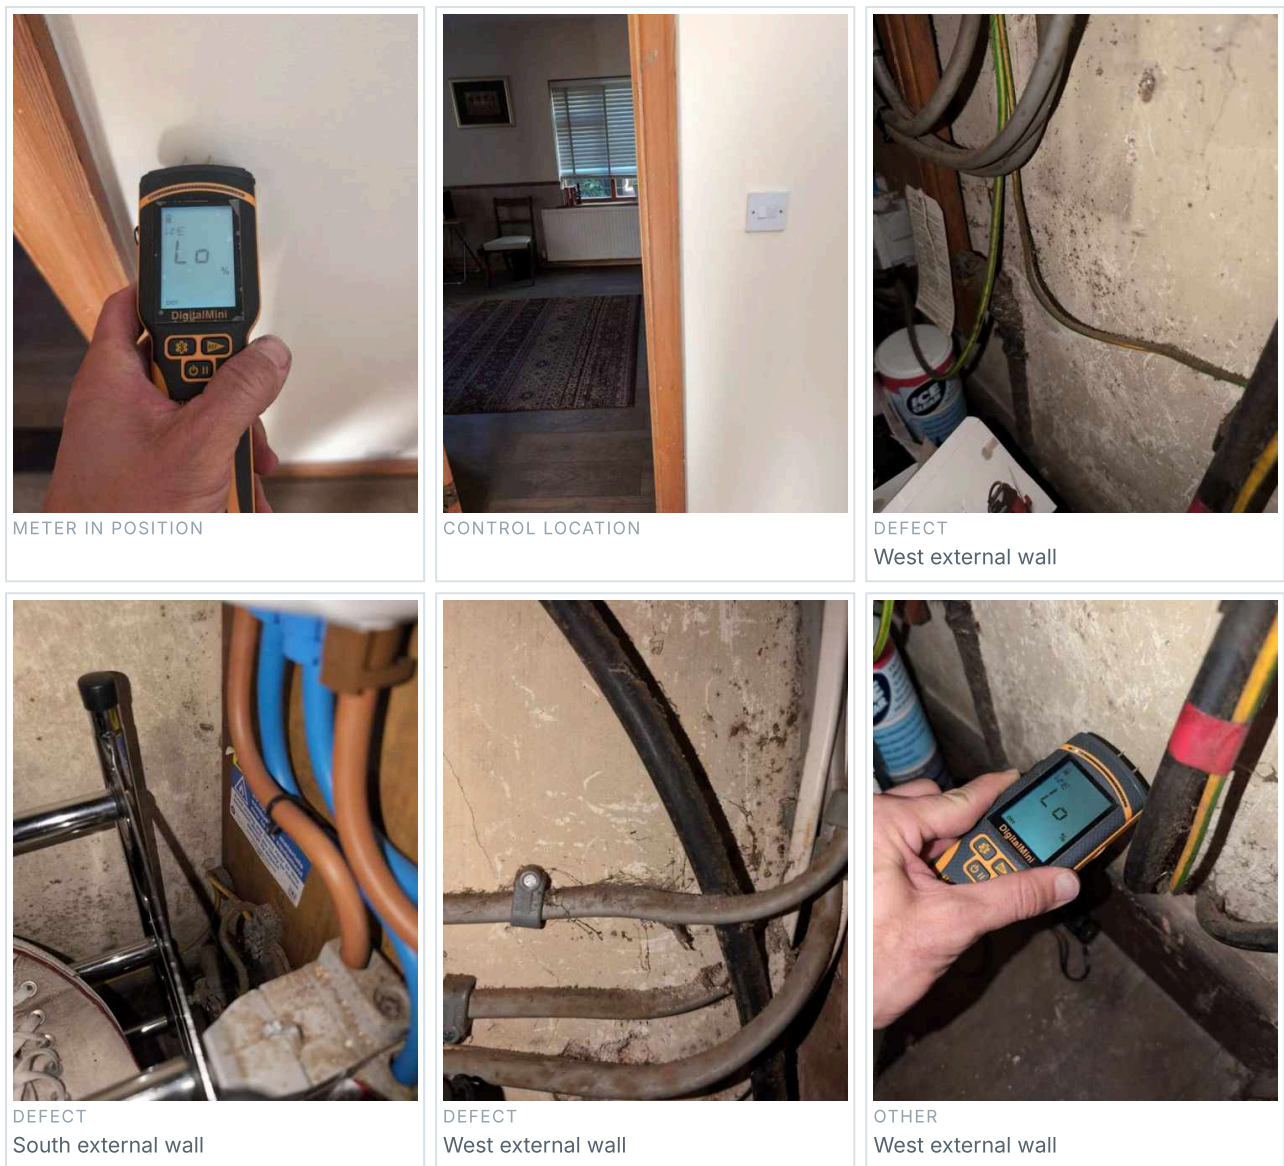
DEFECT  
West external wall

DEFECT  
South external wall

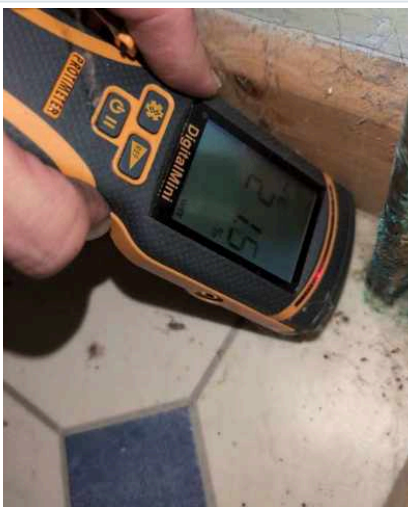
| Floor | <b>11.2 %WME</b> Floor a short distance from the corroded radiator tail |

DEFECT  
Floor reading next to the right hand radiator tail

Second entrance. The walls read below range. At the right hand radiator the copper tail entering the floor is heavily corroded, with staining on the skirting and the wall beside it. The floor reads 21.6 %WME next to the tail and 11.2 a short distance away. That is an active or recent leak at the tail.

#### **1. Have a heating engineer renew the corroded radiator tail in the second entrance and check that the heating system holds its pressure.**

**MODERATE** The floor beside the radiator tail in the second entrance is wet and the tail is heavily corroded. A slow loss of pressure is the usual sign of a weep elsewhere in the pipework, so the system pressure should be checked at the same visit.

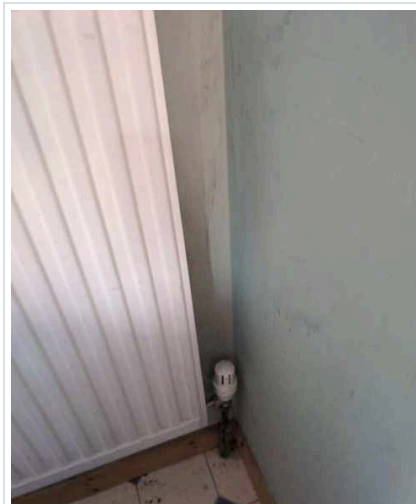
DEFECT  
Wall staining beside the radiator
