# Vigilant Surveys

DAMP AND MOULD INVESTIGATION

## Mid terrace house, Suffolk

Inspected October 2026

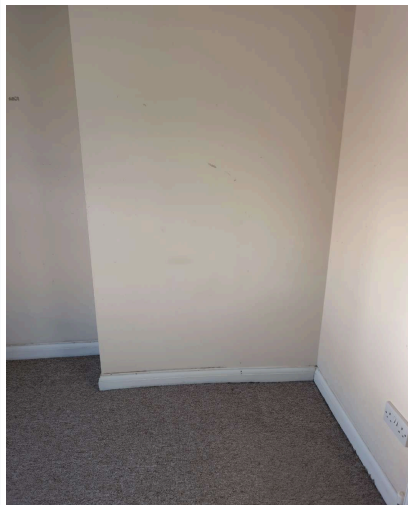
| Flue | <b>NOT VENTED IN THE ROOM</b> The breast is not vented in the room. A flue that is not ventilated at both ends stays cold and still. That is the condition in which flue condensation forms and in which hygroscopic salt contamination of the breast develops, and it is why a breast can read wet on a wall that has no other source of water available to it. |

DEFECT  
Unvented chimney breast

**MODERATE** Both pots are open, so rain falls straight down the flues. The bedroom 1 breast is sealed with no vent, so any moisture in that flue has no way out. The breasts read dry at the inspection, so this is preventive.

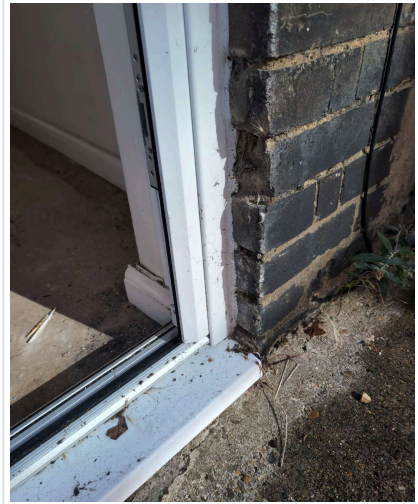
DEFECT  
Outside, the same corner beside the front door

The front door corner. Low in the corner beside the front door the readings are 20.6, 23.3, 34.2 and 42.3 %WME, against 8.8 to 10.3 elsewhere in the room and a control of 8.9. Outside at the same corner the telephone cable passes through the base of the wall with a poor seal, the mortar at low level has blown, and the lowest courses are painted. The concrete footway runs level and hard up to the wall, and no damp proof course is visible. Rain splashing back off a hard surface wets the base of a wall and can carry over a damp proof course, and paint on the brick holds that water in. The leaking gutter end cap sits directly above this corner, so the water escaping from it runs down onto the same place. The gutter at the party line also has no end cap. This is a localised patch with clear routes for water to get in, not a band along the wall.

The order matters. Clean the mould and get air moving through the house first: a working bathroom fan ducted outside, background ventilation in every room and door undercuts. Seal the front cable entry, repoint the base of the front wall and repair the gutters. Inspect the loft for the source of the stains and the insulation over bedroom 1. Redecorate only once the walls have had a drying period. A damp proof course is not called for: the readings show no rising pattern.

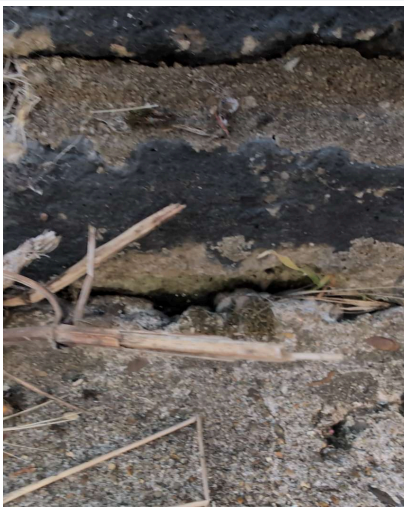
DEFECT  
Outside, the base of the wall at the cable entry

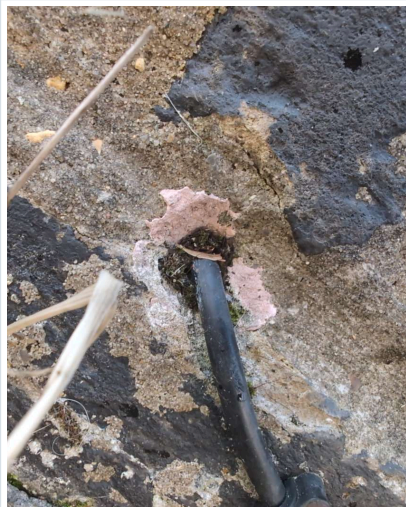
DEFECT  
The telephone cable entering through the base of the wall

| Penetrating damp, building defect | <b>SUPPORTED</b> | Low in the corner beside the front door the readings reach 20.6 to 42.3 %WME against 8.8 to 10.3 in the rest of the room. Outside at the same corner the telephone cable enters through the base of the wall with a poor seal and the mortar has blown. In bedroom 2, 18.7 at about 1200mm left of the window roughly corresponds to patched brickwork outside. |

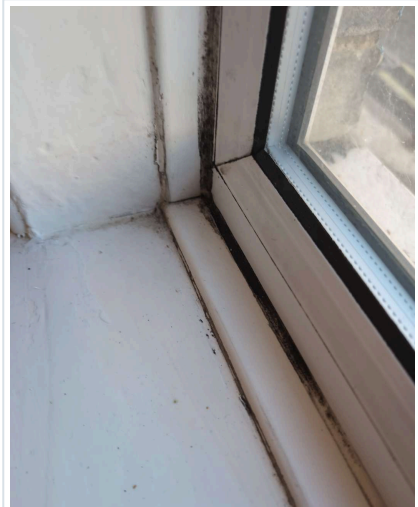
DEFECT  
Mould to silicone

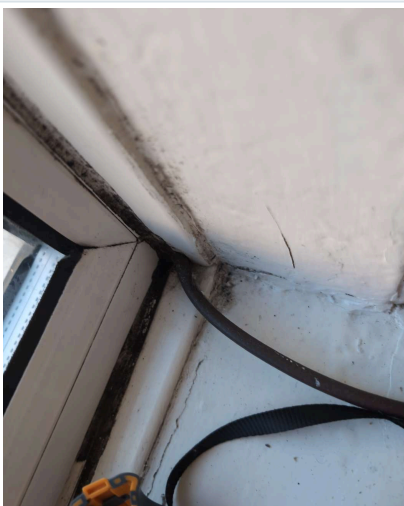
DEFECT  
Mould to silicone

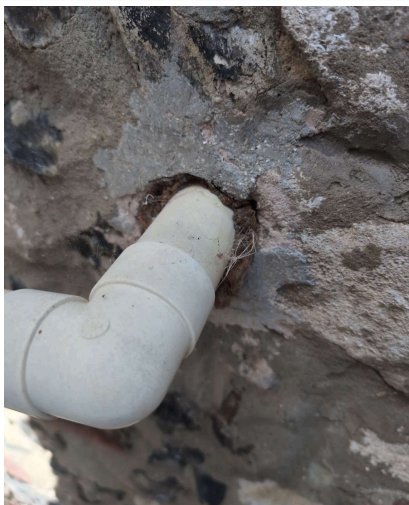
POINTING RENDER  
Waste pipe through the wall, unsealed

The rear. The concrete yard falls away from the wall. The downpipe by the back door runs into the ground with no inspection access, so where it discharges could not be seen. A waste pipe passes through the wall with an unsealed gap, and the flashing at the roof abutment is in poor condition and holding debris.

**MODERATE** The downpipe runs into the ground with no inspection access, so its route is unproven, and the open gap around the waste pipe and the poor flashing are routes for water into the rear wall. These are maintenance points rather than proven causes.

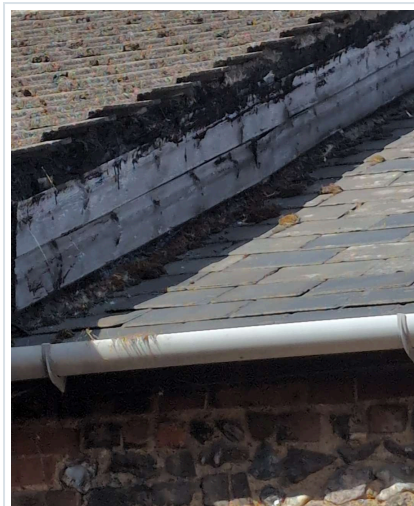
PENETRATIONS  
Flashing at the roof abutment

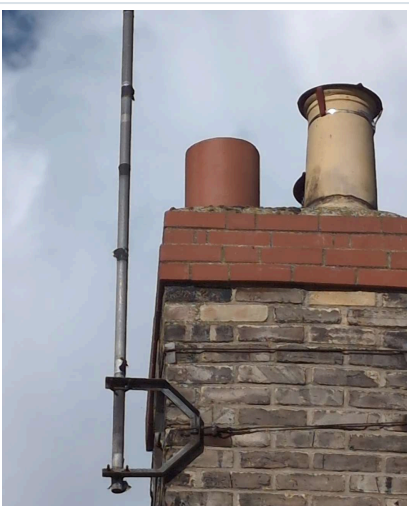
DEFECT  
Chimney stack, both pots open with no cap
