# Vigilant Surveys

DAMP AND MOULD INVESTIGATION

## Victorian semi detached house, North London

Specimen report

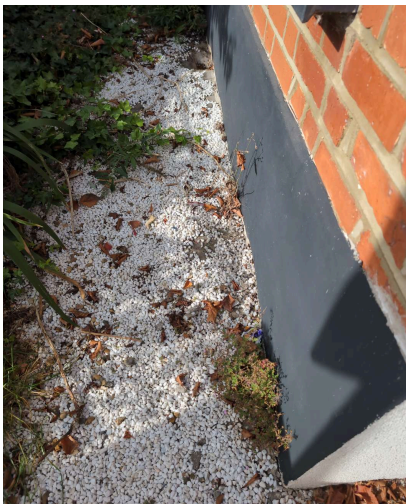
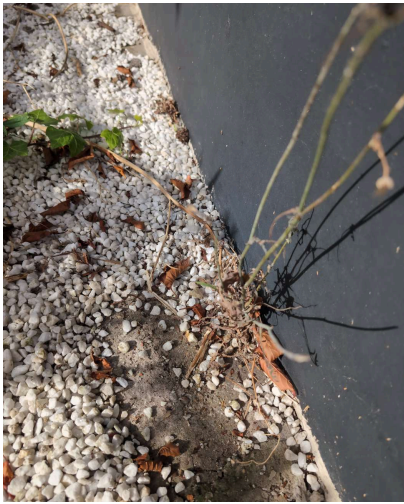
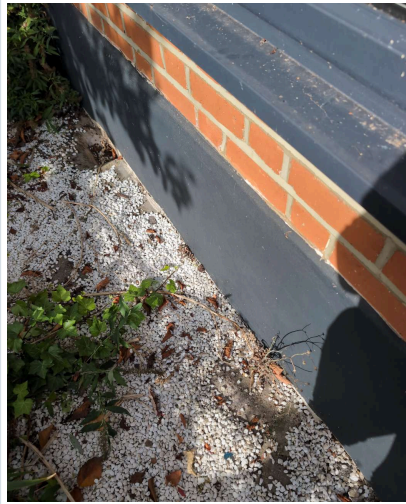
Outside, at the front. A slate damp proof course is visible at the corner of the bay. A painted render plinth to about 600mm runs down past it into the ground, so it bridges the damp proof course. The ground has been built up with concrete against the wall, with gravel over it, and at worst sits only 70mm below the damp proof course, left of the front step, where 150mm is the usual minimum. The air bricks sit at ground level, partly blocked by gravel and mortar. The canopy roof over the bay and front door meets the wall with an old cement fillet, degraded in places, and its gutter is not fitted correctly. There is loose mortar at the bottom right of the front window.

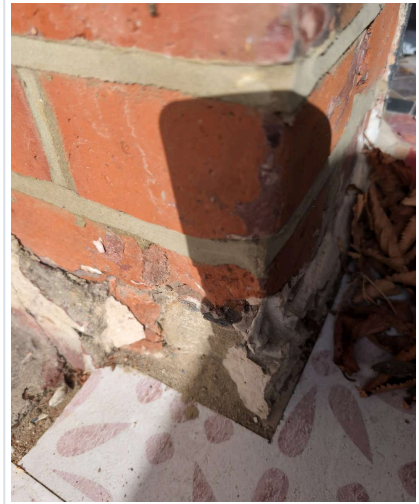
OTHER  
DPC slate

| MECHANISM | VERDICT | EVIDENCE |
|---|---|---|
| Bridging or construction defect | <b>SUPPORTED</b> | At the front, the render plinth runs down past the slate damp proof course into the ground, and the ground has been built up with concrete to within 70mm of the damp proof course. At the rear and along the rear side wall of the kitchen projection, the render sits in contact with the paving. Both bridge the damp proof course, and both hard surfaces throw rain back onto the base of the wall. The kitchen external side wall reads 14 to 20 %WME at skirting level against a control of 8.8. |
