# Vigilant Surveys

DAMP AND MOULD INVESTIGATION

## Detached house, Essex

Inspected September 2026

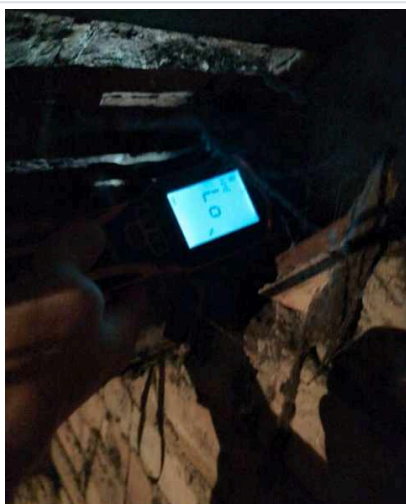
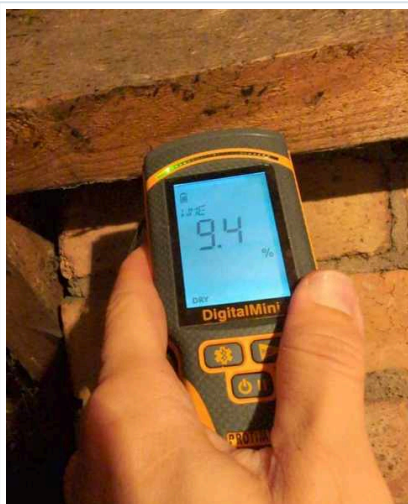
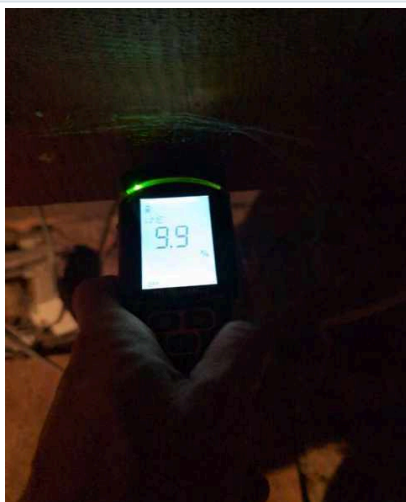
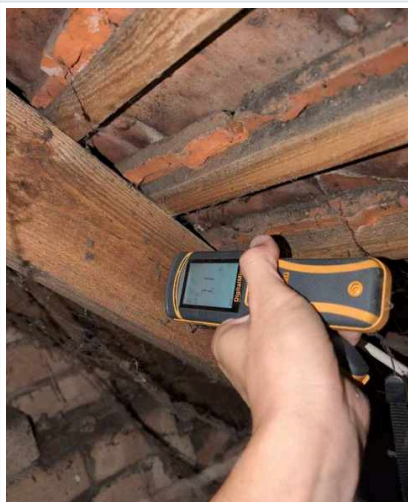
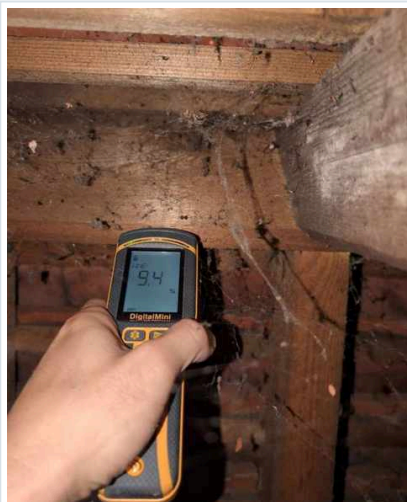
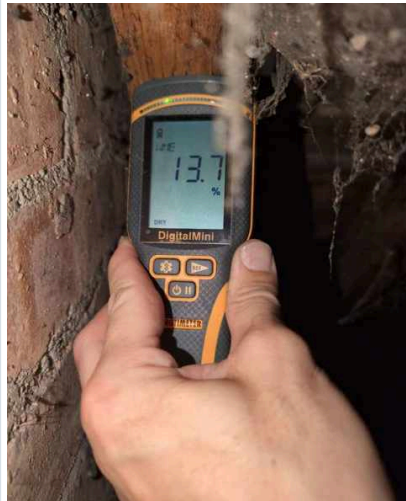
**17.8 %WME** Underside of a tile batten between the rafters above the loft hatch, in the bay with the gap in the tiles, batten and tiles stained

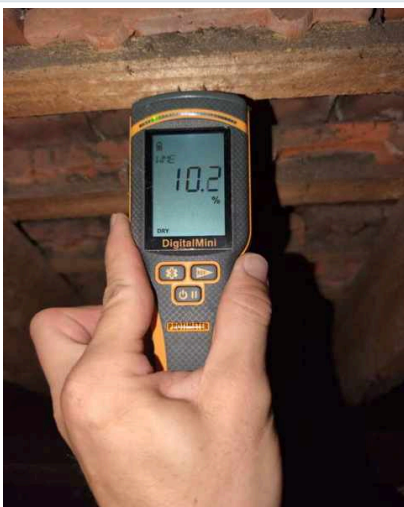
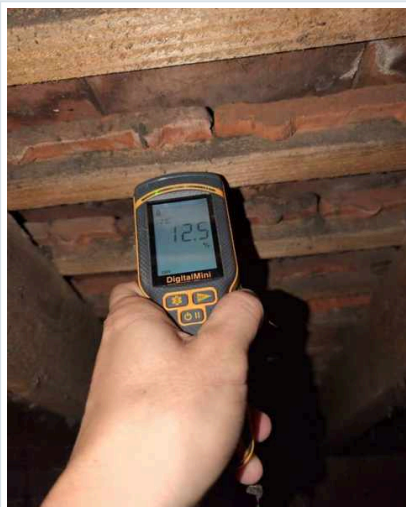
DEFECT  
Gap in tiles course

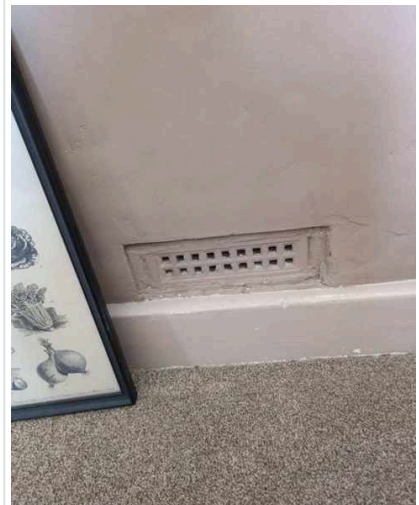
OTHER  
Chimney breast vent

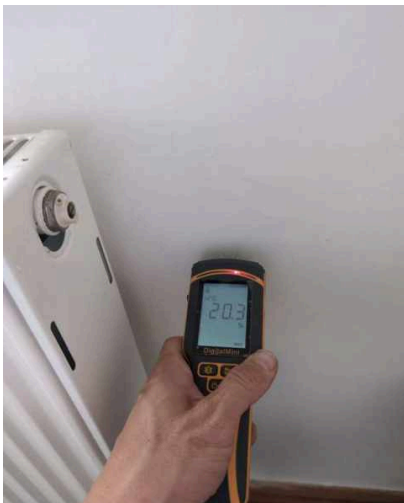
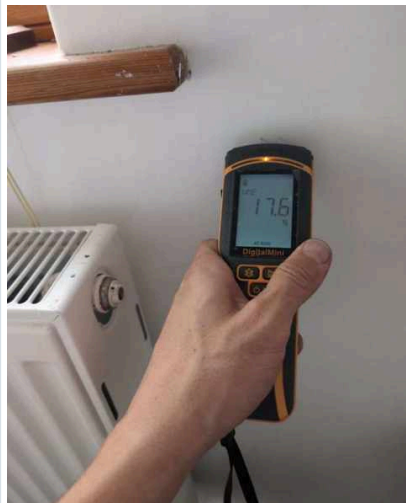
DEFECT  
South external wall

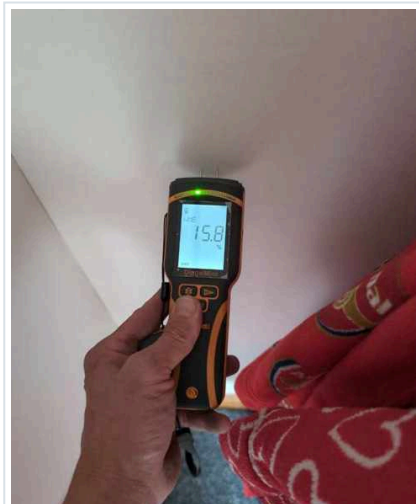
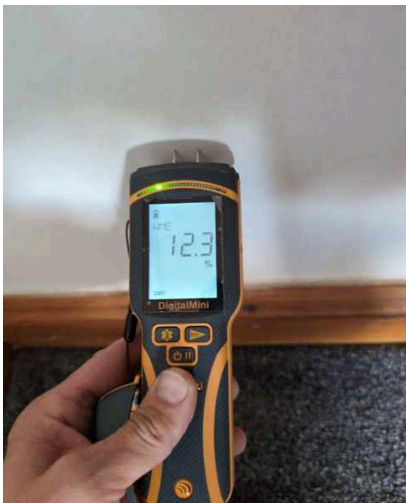
OTHER  
North internal partition wall

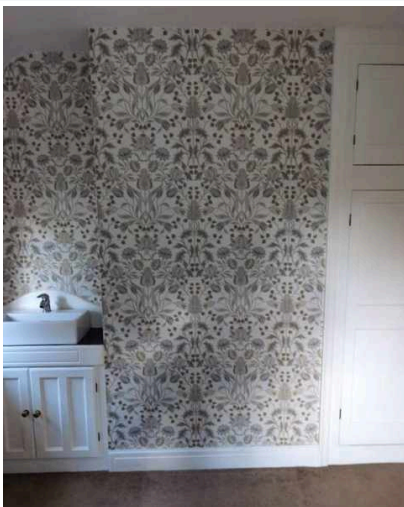
| Flue | <b>NOT VENTED BOTH ENDS</b> The flue is sealed, with no ventilation. A flue that is not ventilated at both ends stays cold and still. That is the condition in which flue condensation forms and in which hygroscopic salt contamination of the breast develops, and it is why a breast can read wet on a wall that has no other source of water available to it. |

OTHER  
Chimney breast, sealed

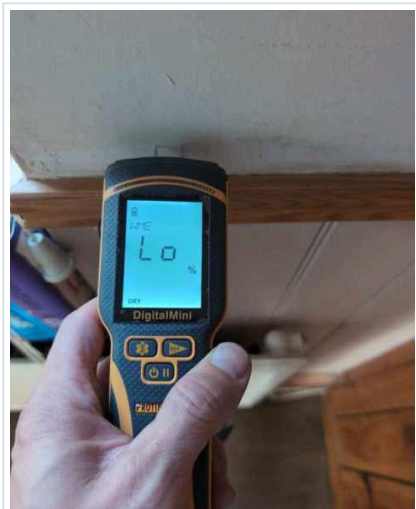
OTHER  
East external wall

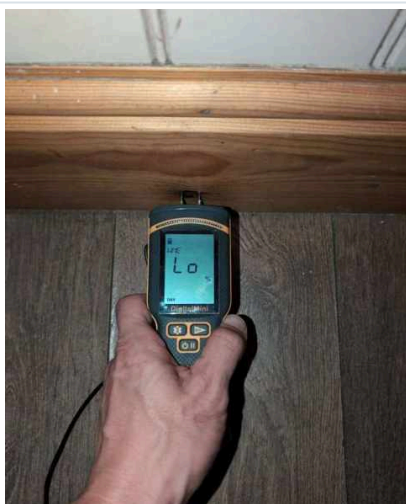
OTHER  
North external wall

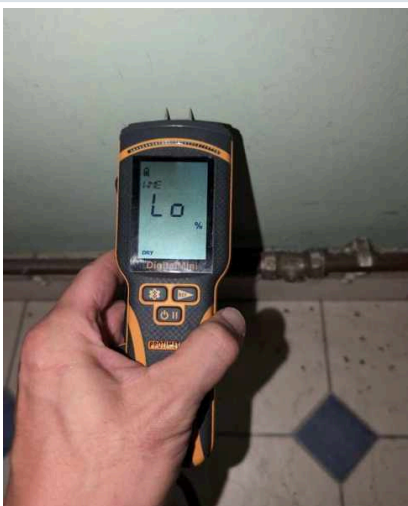
OTHER  
East external wall

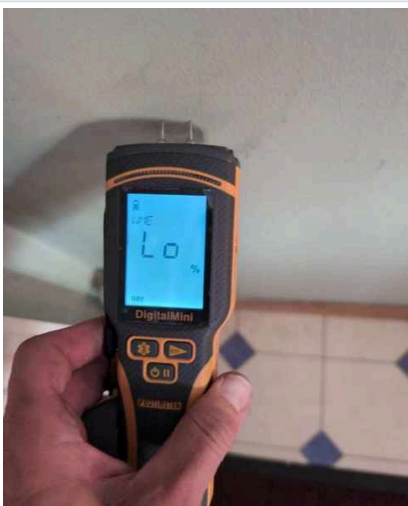
OTHER  
North external wall
