# Vigilant Surveys

DAMP AND MOULD INVESTIGATION

## Mid terrace house, Suffolk

Inspected October 2026

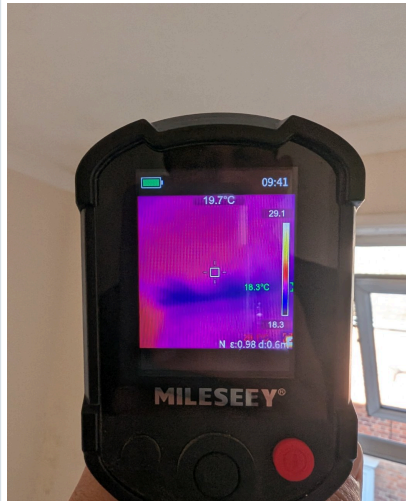
THERMAL  
Thermal image, cold band at the front wall and ceiling junction

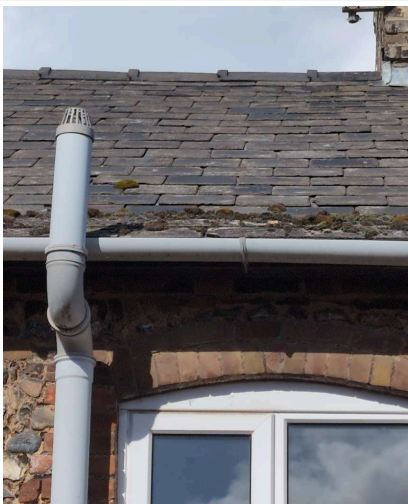
ROOF VISIBLE  
Rear roof slope
