# Vigilant Surveys

DAMP AND MOULD INVESTIGATION

## Detached house, Essex

Inspected September 2026

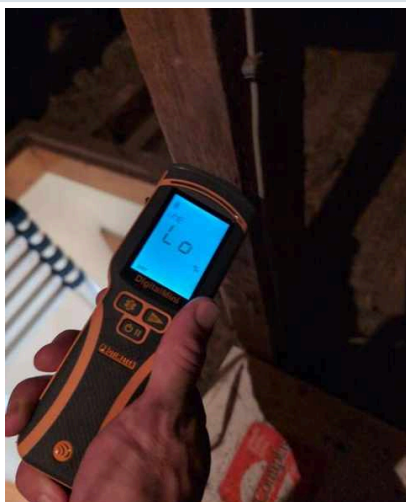
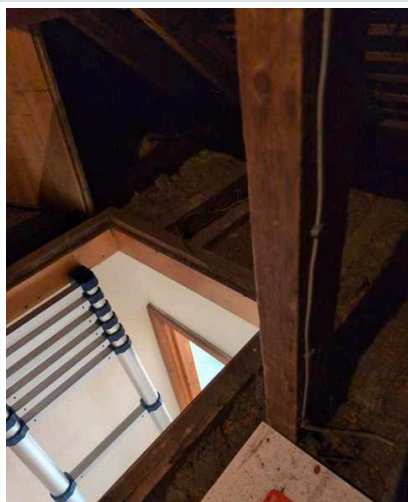
**17.8 %WME** Underside of a tile batten between the rafters above the loft hatch, in the bay with the gap in the tiles, batten and tiles stained

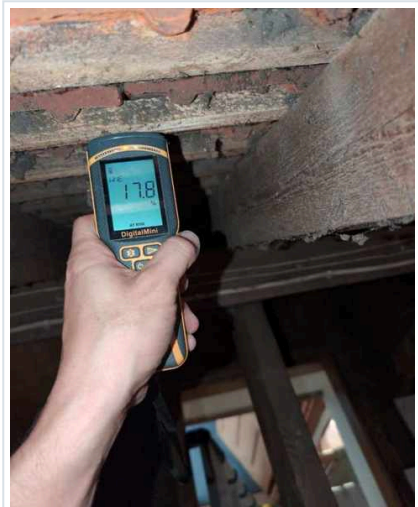
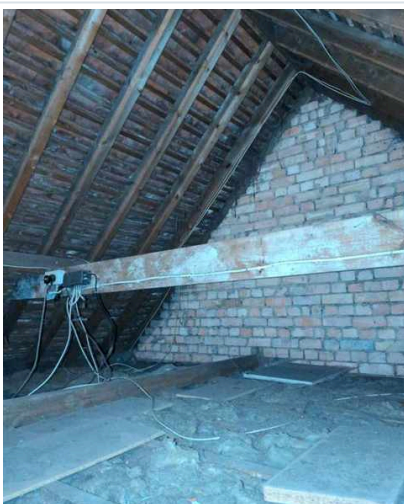
DEFECT  
Gap in tiles course

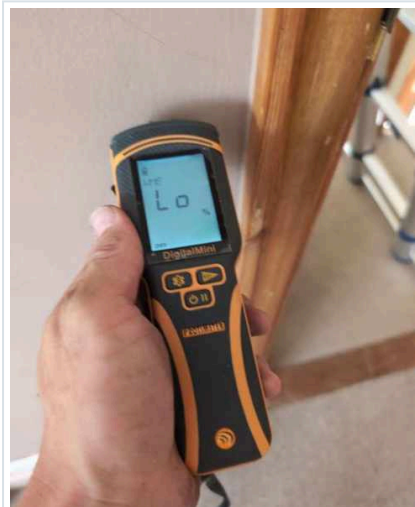
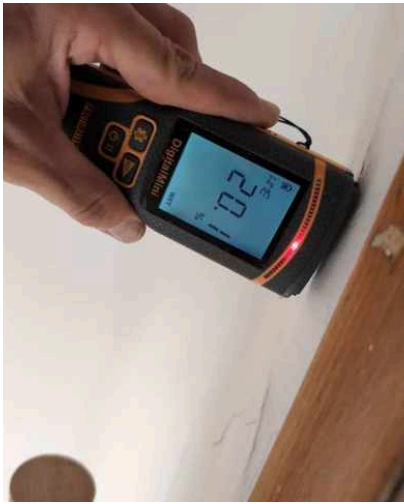
| Wall | <b>20.1 %WME</b> Front external wall, plaster between the picture rail and the ceiling at the top right of the window, cracked and blown |

| Other observations | Blown or hollow plaster |

DEFECT  
External front elevation wall

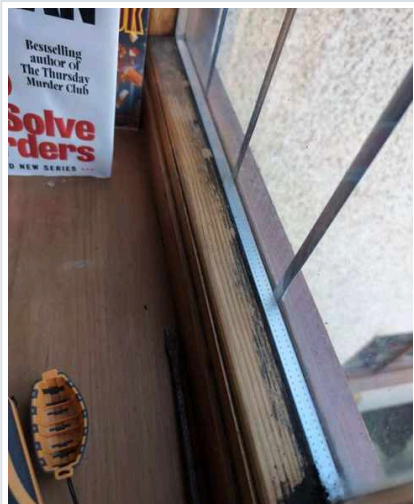
| Visible mould | Trace |
| Other observations | Mould to reveals |

DEFECT

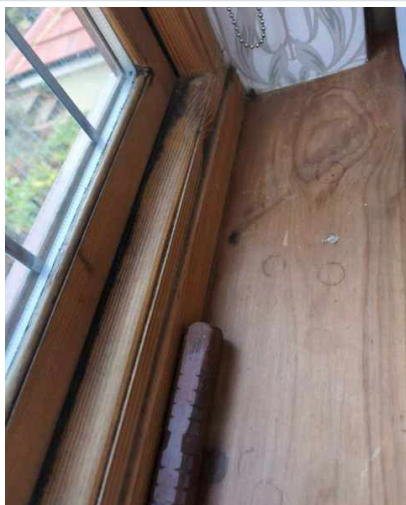
DEFECT

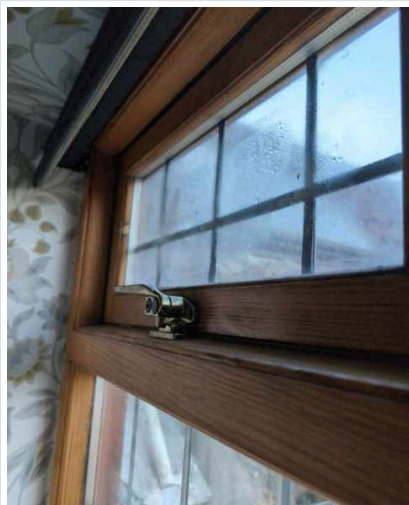
DEFECT

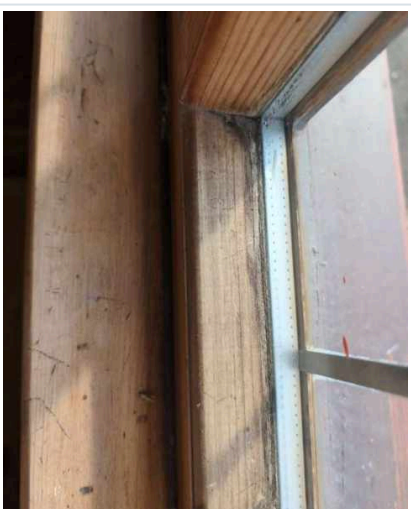
| Other observations | Staining |

DEFECT

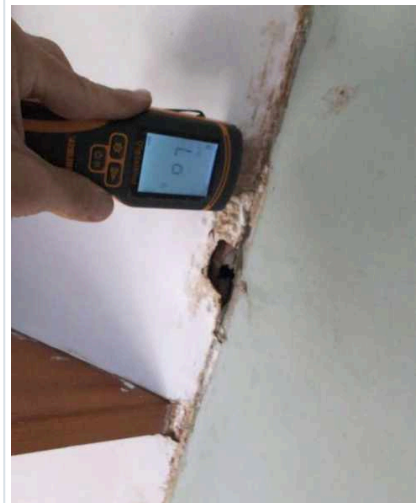
| Junction | <b>12.5 %WME</b> Ceiling and wall junction beside the timber beam, at the damaged area beneath the rooflight |
| Observed | Blown or hollow plaster, Staining, Mould, Water marks, Salting efflorescence |

DEFECT

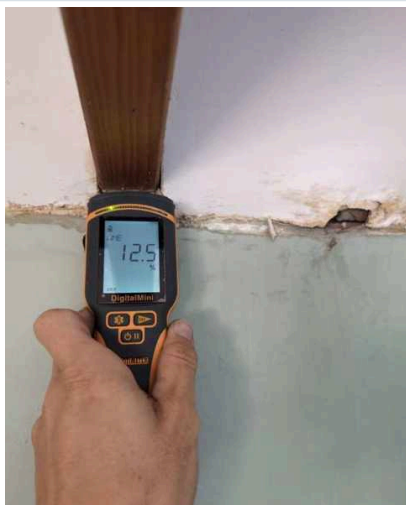
DEFECT

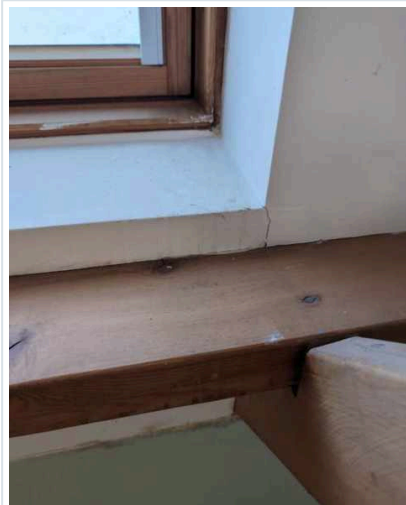
DEFECT

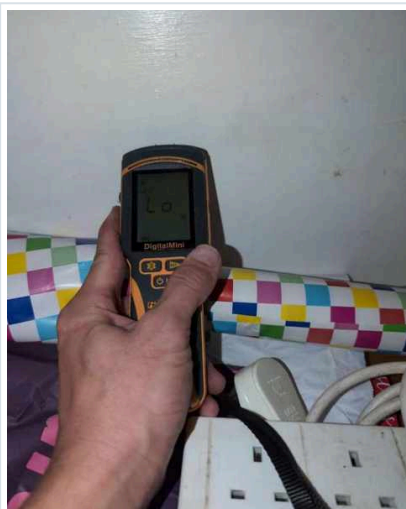
OTHER  
South internal wall

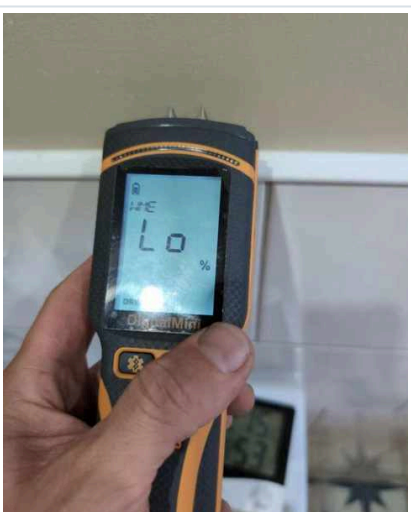
OTHER  
South internal wall

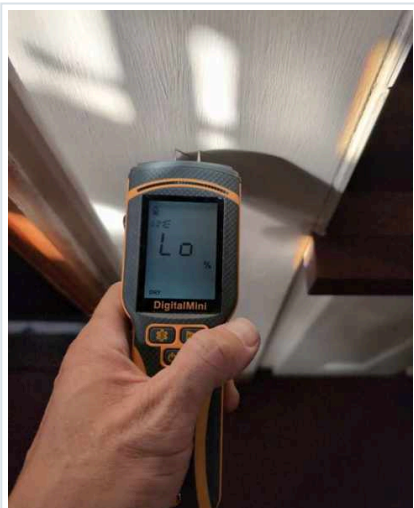
OTHER  
North wall

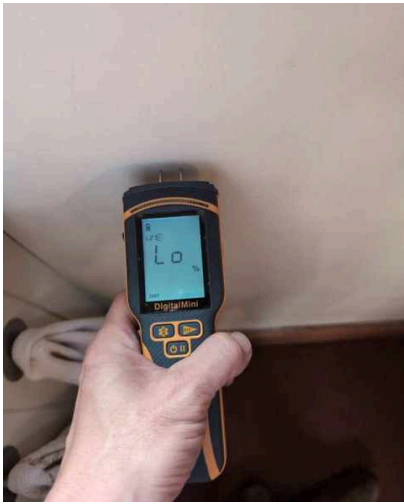
OTHER  
West wall

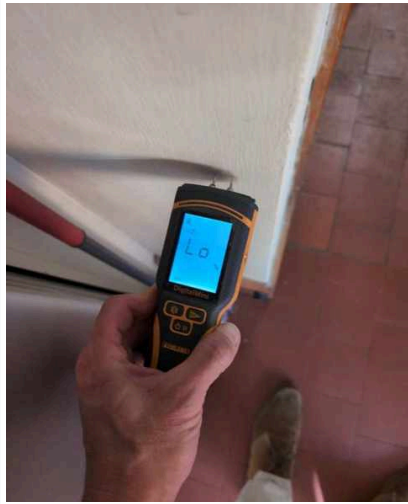
OTHER  
South wall

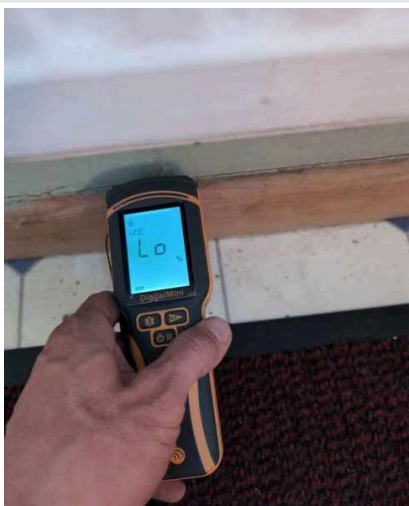
OTHER  
West external wall

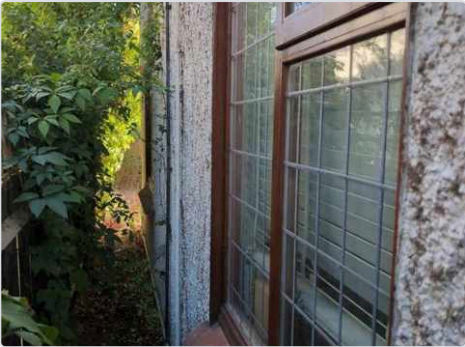
East

| Ground to damp proof course | <b>MARGINAL</b> At its worst point, clear by approximately 15mm. The length of this elevation Along the length of this elevation. |
| Chimney stack | <b>NOT VISIBLE</b> The stack on this elevation could not be seen from ground level and was not inspected. |
