# Vigilant Surveys

DAMP AND MOULD INVESTIGATION

## Mid terrace house, Suffolk

Inspected October 2026

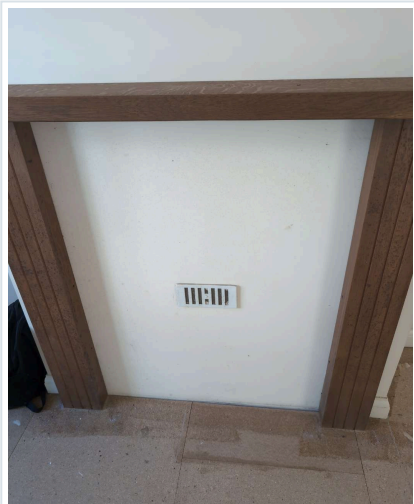
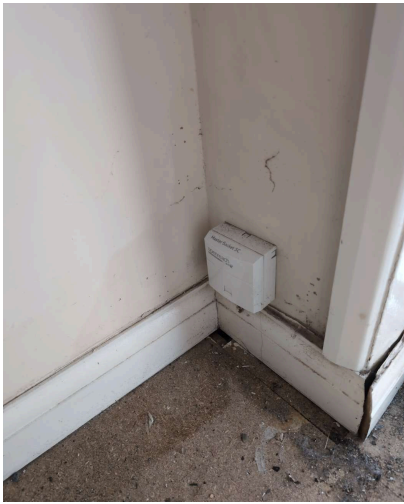
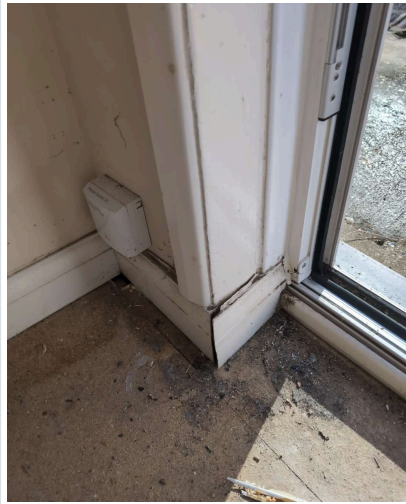
| Other observations | Mould to reveals, Staining |

| Penetrating damp, building defect | <b>SUPPORTED</b> | Low in the corner beside the front door the readings reach 20.6 to 42.3 %WME against 8.8 to 10.3 in the rest of the room. Outside at the same corner the telephone cable enters through the base of the wall with a poor seal and the mortar has blown. In bedroom 2, 18.7 at about 1200mm left of the window roughly corresponds to patched brickwork outside. |
| Plumbing or drainage leak | <b>SUPPORTED</b> | Brown stains with tide marks on the ceilings of bedroom 1 and the living room are the marks water leaves as it dries. The stained ceiling in bedroom 1 reads 8.3 and 10.6 %WME, in the dry band, so a past escape of water is supported but there was no sign at the inspection that it is still live. The loft could not be reached to look for the source. |

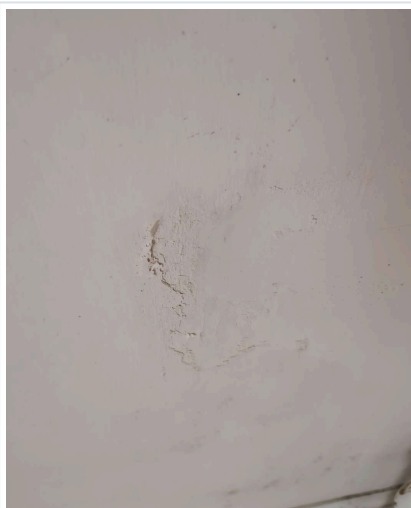
| Observed | Salting efflorescence, Peeling paint, Staining |

| Other observations | Staining, Salting efflorescence, Peeling paint |

| Salt contamination of plaster | <b>SUPPORTED</b> | On the kitchen party wall 69.7 and 47.0 %WME at 600mm sit beside 8.4 in the same row and 9.3 directly above. Water spreads through a wall, salts do not, so a sharp edge like that is the signature of salts. Powdery deposits and lifting paint were seen at the same place. An electrical meter reads salts and moisture alike. |

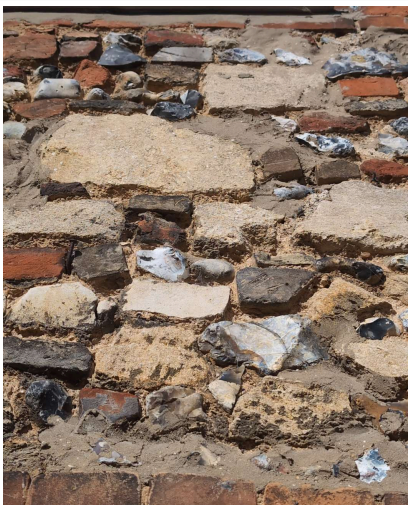
POINTING RENDER  
Rear walling

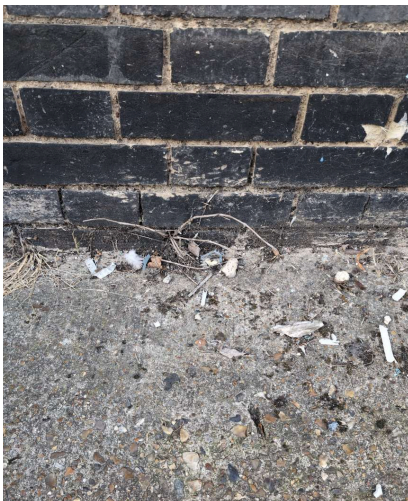
Front gutter and downpipe at the party  
line

| Penetrating damp, wind driven rain | <b>SUPPORTED</b> | At the front the concrete runs level and hard up to the wall, and rain splashing back off it wets the lowest courses, which are painted and hold the water in. The front gutter end cap leaks and the gutter at the party line has no end cap. The leaking end cap sits directly above the front door corner, where the readings are highest. |
